McLaren 720S and 750S Lower Bodyside Not Flush

Location: Body Panels & Closures

Topic: New repair instructions in the McLaren Service Portal for when the lower bodyside does not sit flush

Condition: Lower body panel not flush or bulging out

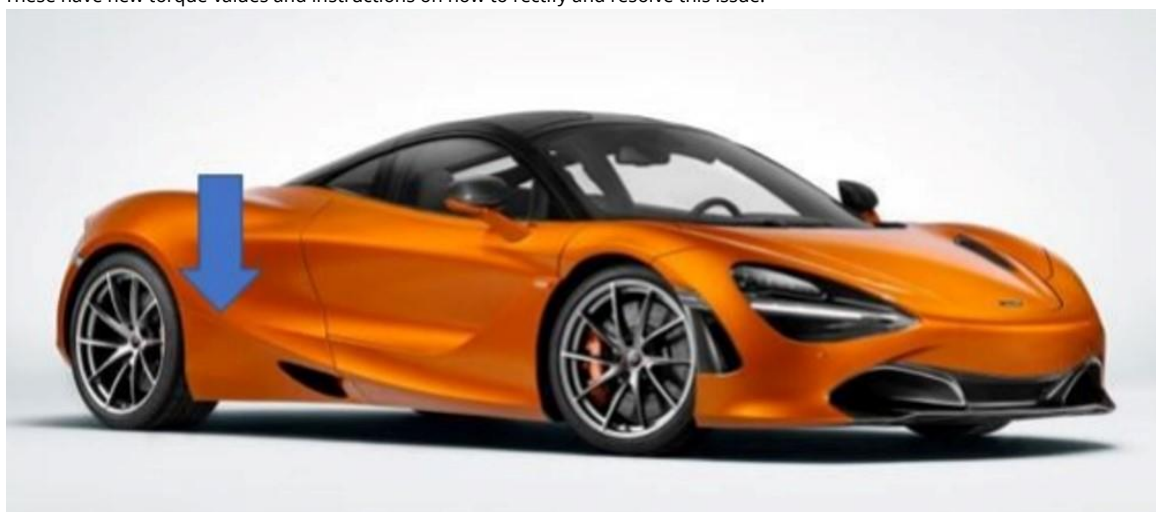
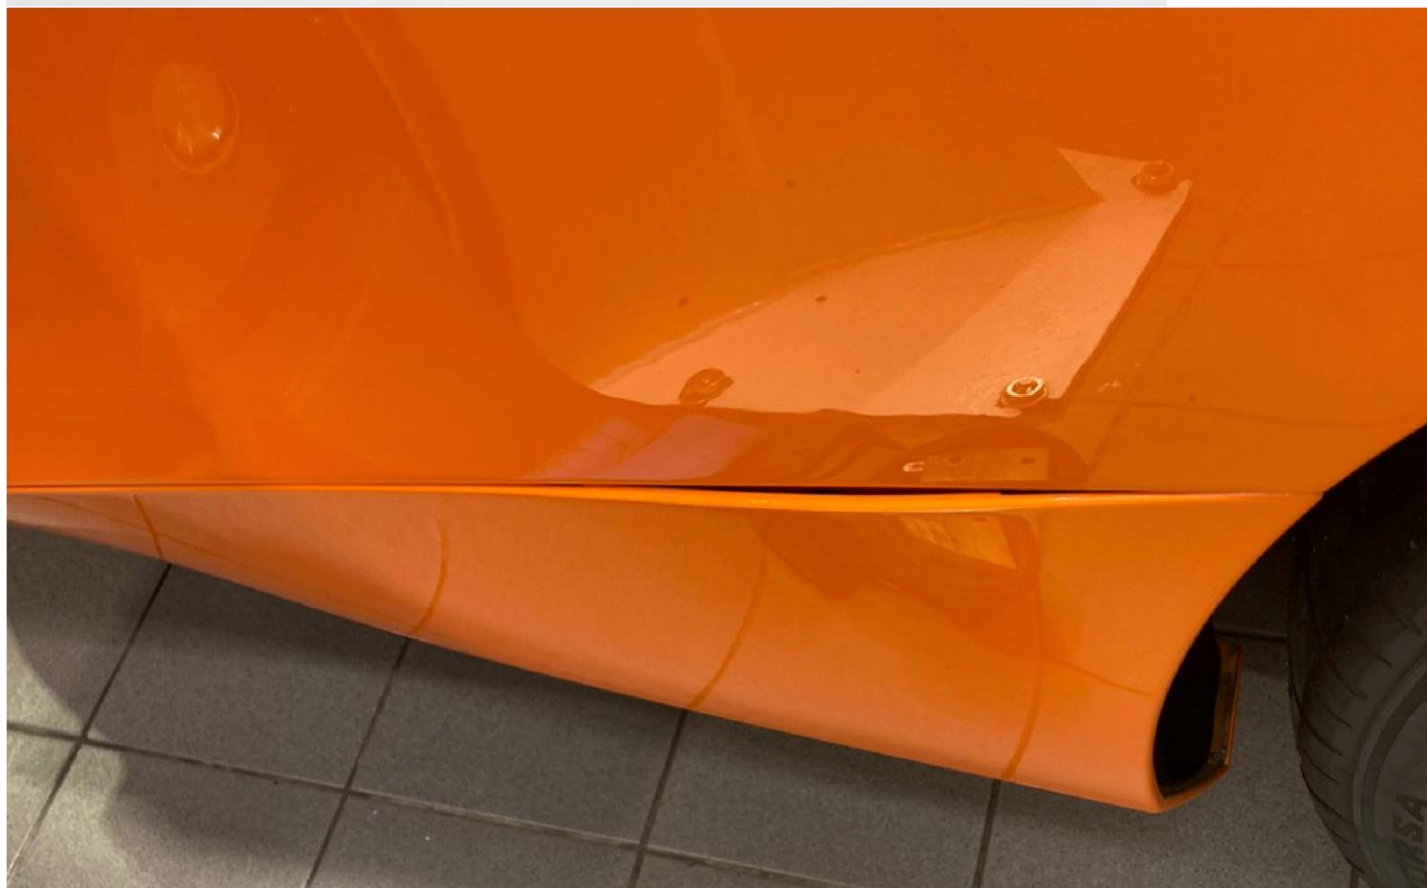
If there is a concern raised of the lower bodyside not fitting flush (bulging out), please refer to the new repair instructions in the McLaren Service Portal.

The instructions can be found under Rework Bodyside Lower Panel in the McLaren Service Portal.

These have new torque values and instructions on how to rectify and resolve this issue.
