McLaren Artura Transmission Oil Leak Diagnosis Guide (V2)

Location: Powertrain / Hybrid

Topic: McLaren Artura Transmission Oil Leak Diagnosis Guide

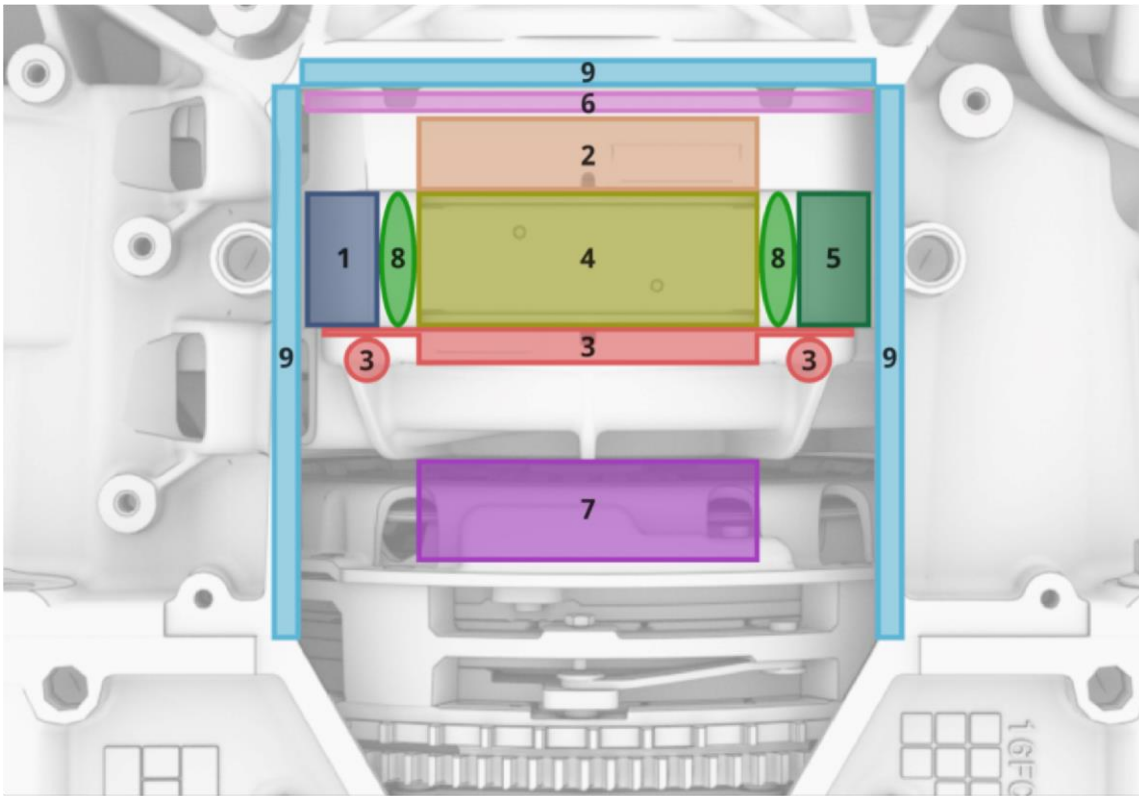
Oil Types				
Location	Clear dielectric oil, no UV reaction	Yellow tinge dielectric oil, hint of UV	New transmission oil, golden, green UV reaction	New engine oil, green UV	Red grease
1 Dark Blue					
2 Orange					
3 Red					
4 Yellow					
5 Dark Green					
6 Pink					
7 Purple					
8 Light Green					
9 Light Blue

14. If leak continues post cycle 5 please fill in table in accordance with the leak path map below. Check dielectric oil level when vehicle has cooled down and attach table, dielectric oil level and all images to a TR If no leak present after overnight dwell period, no further action required.
