Technical product information

Topic	Water ingress into the front cabin footwell/bulkhead - Glass misting on the inside - Front carpets/mats wet
Market area	Bentley: worldwide (2WBE), China 796 VW Import Comp. Ltd (Vico), Beijing (6796)
Brand	Bentley
Transaction No.	2075713/1
Level	EH
Status	Approval
Release date

New Continental GT / C and New Flying Spur

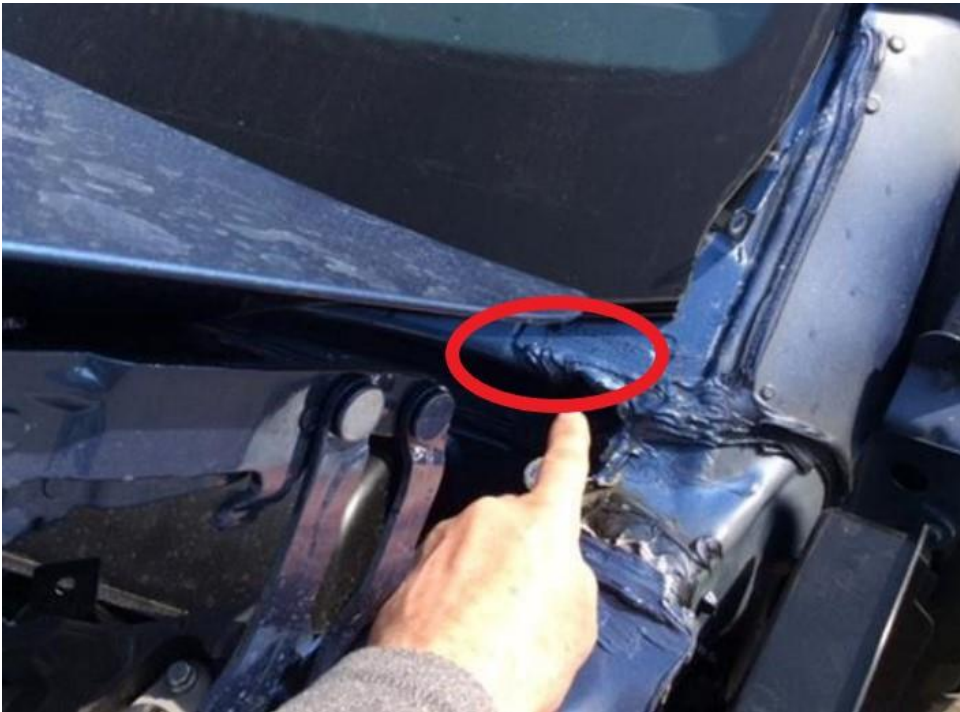
- After conducting TPI 2062622/- water ingress was found at the location shown in Figure1 (Left hand A - Pillar seam)

Figure 1 - Shows the front left hand wing removed please note this is not required for this procedure unless advised via a new or existing DISS query

Hint: The example shows a leak on the left hand side although a leak could be evident on the right hand side at the same location

- 1) Referring to Rep.Gr 55 - Remove the plenum cover
 - Check the condition of the seam sealant at the location shown in Figures 1 and 2
 - Check to confirm that sealant has been applied to the left hand A - pillar seam
 - Check to confirm that sealant has been applied to the right hand A - pillar seam

A different location the operative should clean/prepare the areas concerned and apply sealant (See parts information) to the applicable location(s)

- Once sealant has been applied conduct a local paint repair in the location in which sealant was missing
- 2) Once the sealant and paint repair has been completed and the sealant/paint has cured/dried - Check to confirm the leak has been successfully repaired
 - 3) Referring to Rep.Gr 55 - Refit the plenum cover
