94-19-01 - Exterior Lights, Moisture Accumulation

Release date: 12/6/2024

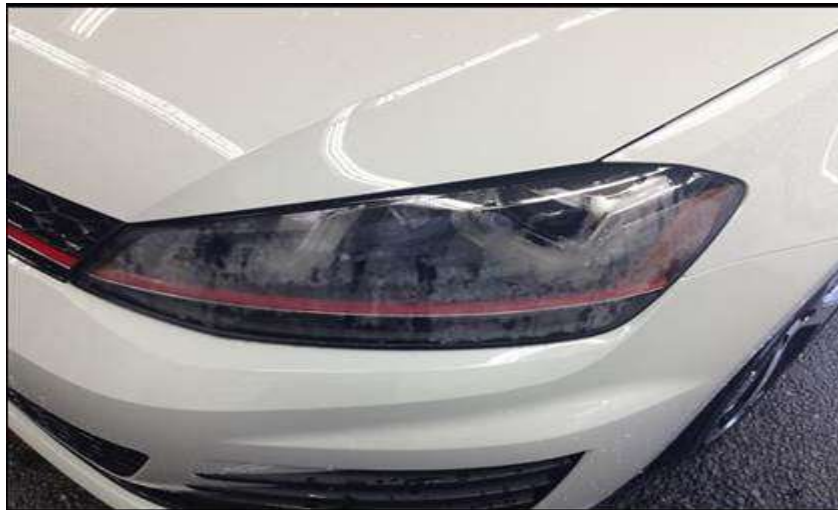
Figure 1

Exterior light assemblies (headlights, taillights with incandescent bulbs, fog lights, turn signals) are vented and may collect moisture on their inner surfaces, depending on humidity and climatic conditions. The unfavorable condensation built up (Figure 1) visible to the customer is more common with modern exterior lights because of clear glass optics, however this condition will not have an impact on the functionality or durability of the component.

For headlight condensation that is due to environmental conditions, the affected lens surface should be cleared after approx. 30 minutes of light operation.

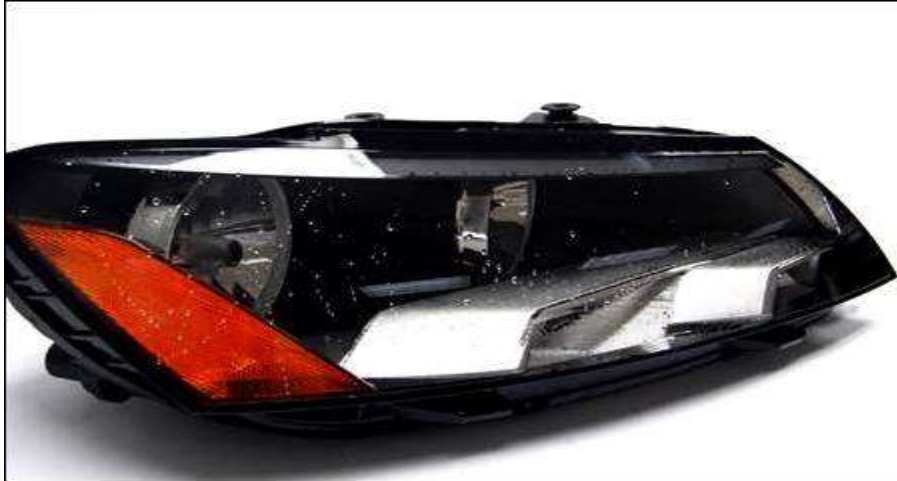
Figure 2

In cases where larger water droplets have formed on the inside of the lens or significant amount of water has collected at the bottom of a light assembly, Figure 2:

Check for leaking seals, cracks in lenses or assemblies.

DO NOT replace light or lens assemblies unless damage is found.

Follow normal repair procedures for this type of failure (provide photograph(s) with repair documentation for verification).
