Technical Service Bulletin

87 Noises from the engine compartment, both while stationary and while driving

87 24 92 2071621/2 December 6, 2024. Supersedes Technical Service Bulletin Group 87 number 23-56 dated October 5, 2023 for reasons listed below.

Model(s)	Year	VIN Range	Vehicle-Specific Equipment
RS 3	2022 – 2024	All	Not Applicable

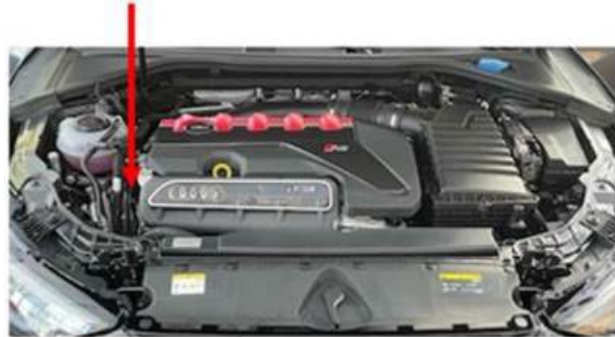
1. Assess the right-side area of the engine compartment near the longitudinal member.

Figure 1. Area of the engine compartment to inspect refrigerant line contact.

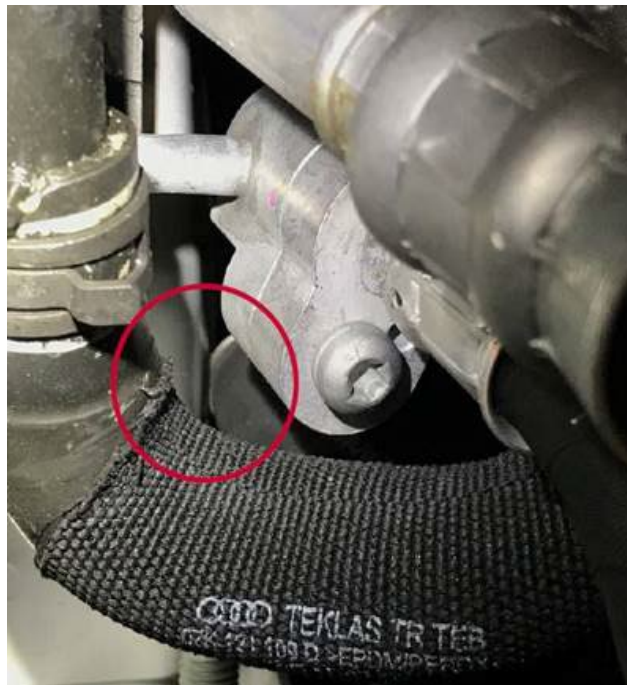
Refrigerant line is in contact with the front right longitudinal member.

2. The refrigerant line may be in contact with the longitudinal member.

Figure 2. Refrigerant line in contact with longitudinal member.

4. Change the route of the refrigerant line and ensure there is a gap of at least 1.5 cm between the refrigerant line and the longitudinal member.
5. When billing, please always attach photos/videos that clearly shows the complaint to DOC-IT. To ensure a reference to the vehicle, the image/video must:
- Include the VIN and date.
 - Must not be edited.
 - Should be in focus and taken with sufficient light. A high resolution is not necessary.

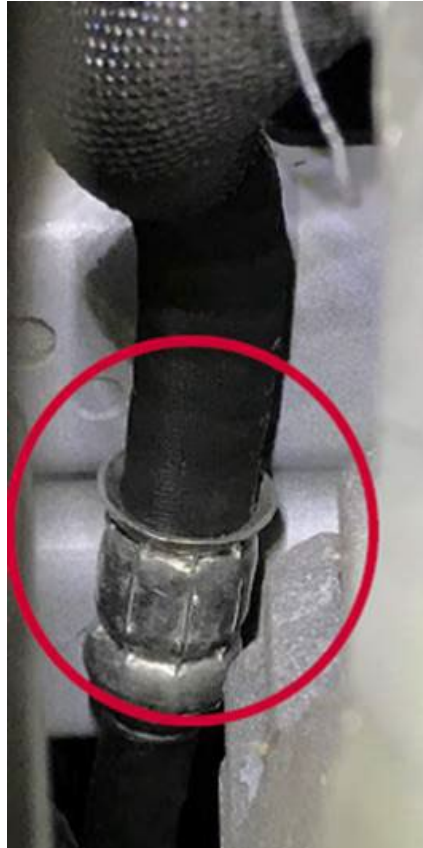
3. Figure 3 shows this contact at a different angle.

Figure 3. Alternative view of refrigerant line contact with longitudinal member.
