# Technical Service Bulletin

## 93 e-tron GE electric drive motor leak P0AA600

93 24 46 2073858/5 December 19, 2024. Supersedes Technical Service Bulletin Group 93 number 24-29 dated November 7, 2024 for reasons listed below.

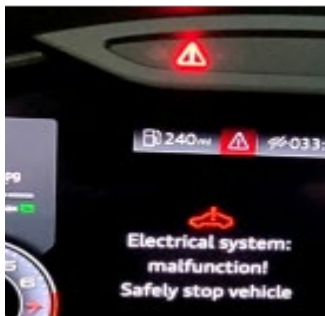
- A Drive System/Electrical System Malfunction message (Figure 1) appears in the in the instrument cluster; the warning may not be present at the time of inspection.

Figure 1. Warning lamp associated with message.
