WRS1 - Checking High-Voltage Battery and Replacing Cell Block Module if necessary (Workshop Campaign)

Model Line: **Taycan (Y1A / Y1B / Y1C)**

Model Year: **As of 2020 up to 2024**

Concerns: **High-voltage battery**

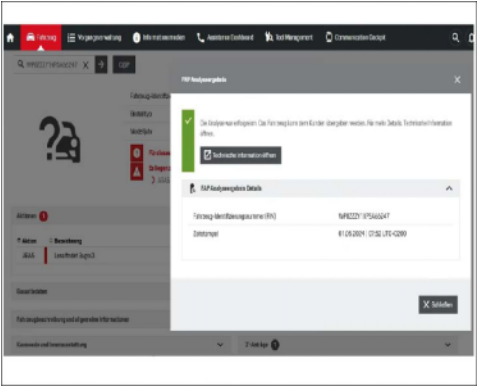
</div> <p><i>"Green" display result</i></p>
---	--

<p>- Green indicator: The test result is “positive”. Cell modules are OK.</p>	<div>

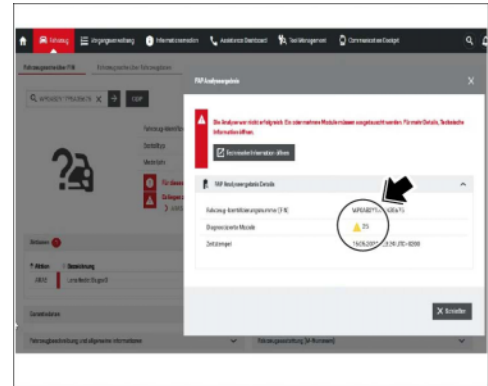
"Red" display result

- **Red indicator:** The test result is **"negative"**.
One or more modules must be replaced.

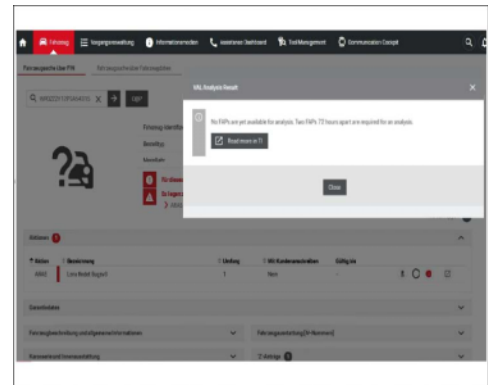
"Grey" display result

- **Grey indicator:** There are no valid VALs. Additional VALs must be created according to the following procedure.

1. Creating and uploading a VAL
2. Charge up to 100% SoC via AC charge port.
3. Create and upload a second VAL after 6 hours of downtime.
4. Create and upload a third VAL after 66 hours of downtime.
5. Check analysis result again in PCSS.
