Advanced Technical Information

Lightweight Glass Panes Cracked – Identification and Possible Causes

Models	Model Year	Model Type	VIN Range	Vehicle-Specific Equipment
911	2021 - 2024	992110 992120 991130 992140 992150 992410 992420 992430 992440 992450 992460 992810 992820 992850	n/a	+VW4

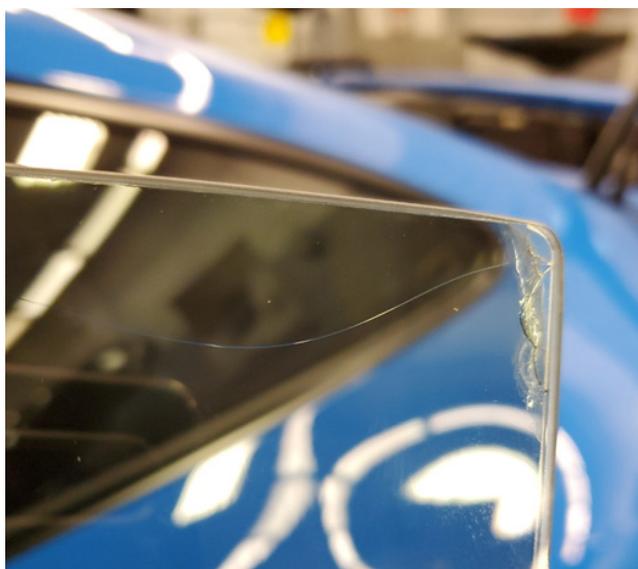
Figure 1 - Door glass: cracks in the top corner

Door glass: Cracks in the top corner (driver or passenger side)

There are two main causes for this condition:

- > The door glass is misaligned, which can cause contact between the door glass and the rear quarter glass, or
- > Force applied to the glass (i.e., instead of the door sill) throughout the door closing process can bend the glass enough to cause contact with the rear quarter glass, despite a proper window alignment with no force applied.

Updated lightweight door glass parts have been developed to address this complaint. Please see the *Door glass: cracks in the top corner* section of the Service Information for repair instructions.

Please replace the affected glass pane(s) with the updated parts (index "H"), as instructed in *WM 644019 – Removing and installing door window glass*.

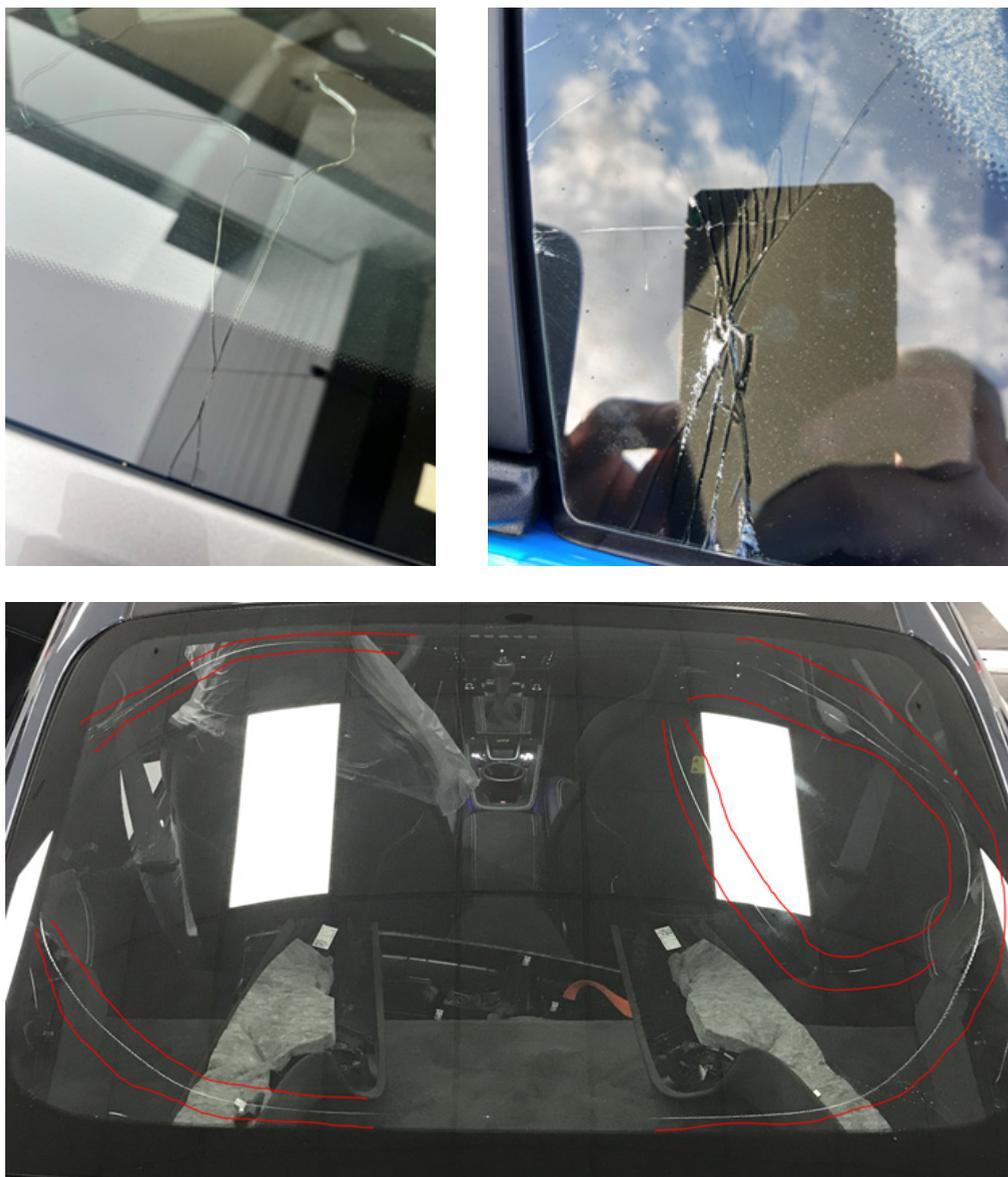
Figure 3 - Rear window glass: various cracks

Rear window glass: various cracks

Stress cracks in the rear window glass are currently being analyzed by Porsche. The root causes for the different kinds of stress cracks are unknown at the time of publication of this document.

Please see the *Rear window glass: various cracks* section of the Service Information for repair instructions.

Please replace the rear window glass as instructed in *WM 648619 – Removing and installing rear window*.

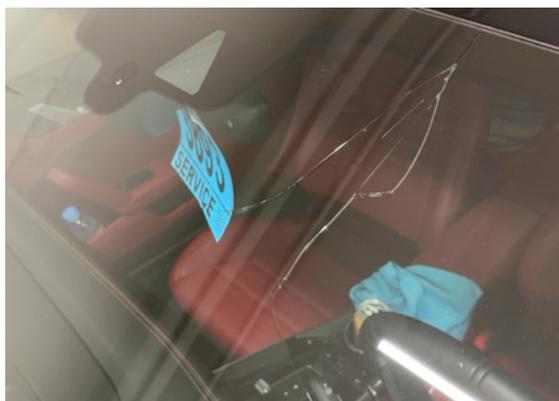
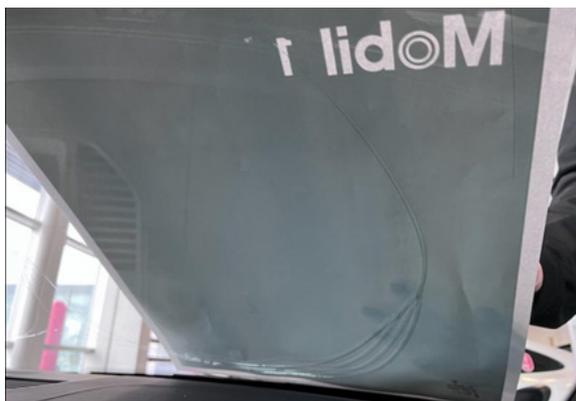
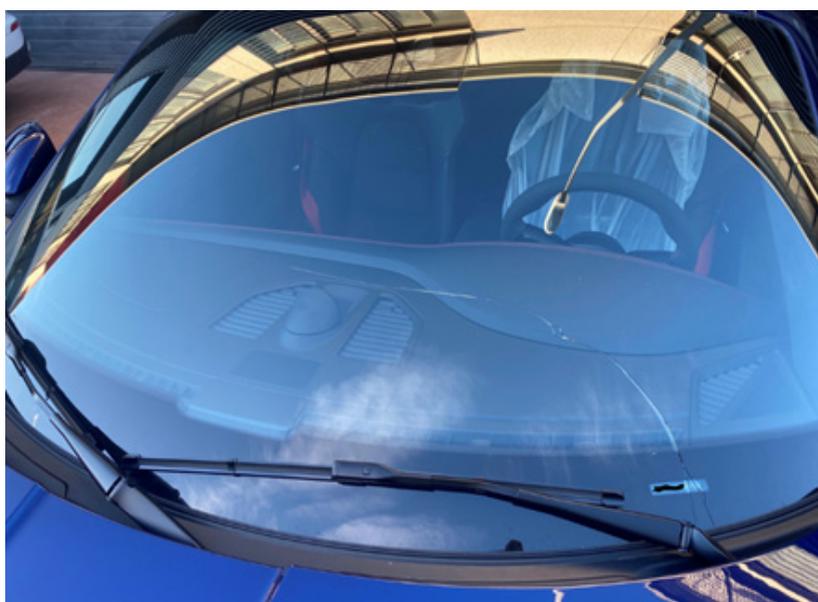
Figure 4 - Front windshield: various cracks

Front windshield: various cracks

The stress cracks in the front windshield are caused by too much stress in the outer glass pane. Updated parts have been developed to address this issue.

Please see the *Front windshield: various cracks* section of the Service Information for repair instructions.

Updated parts are available since September 4, 2023.

Please replace the front windshield as instructed in *WM 641219 – Removing and installing rear windscreed*, with the latest available version in PET.
