TECH TALK - VOLUME 283 NOVEMBER/DECEMBER 2024

SPARE PART INFORMATION: Steering Wheel Remote Control Switch

TECHNICAL INFORMATION: Electrical System Service Required Warning is on

TECHNICAL INFORMATION: Fuel - Hard to fill concerns

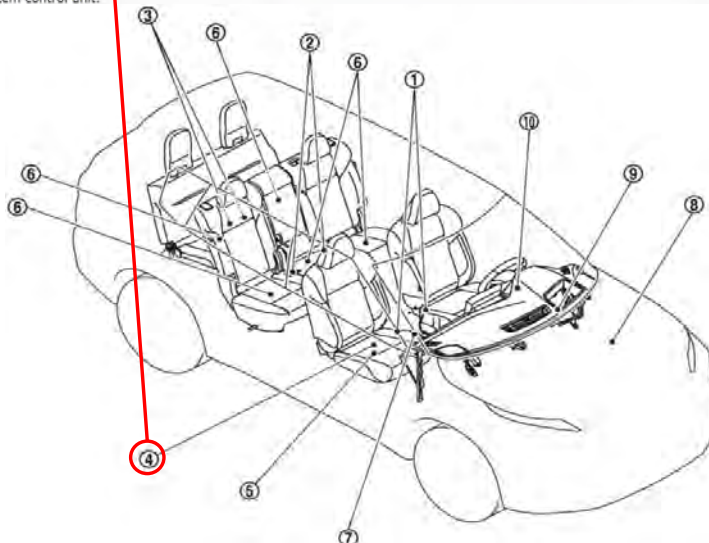
Fig.1

This is to remind you that when you need a new occupant detection system sensor, please order a "PAD, SEAT CUSHION", not a "COVER, SEAT CUSHION". See illustration below.

The seat belt reminder sensor is located in the same position as in previous models.

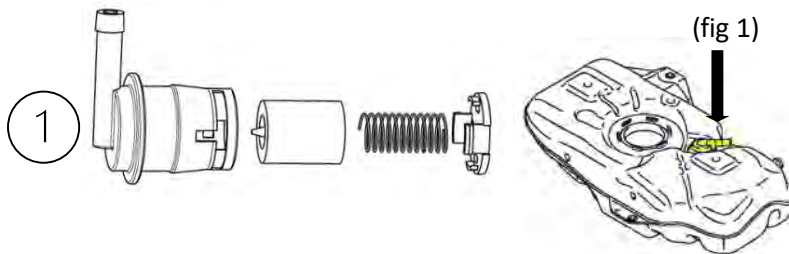
During fueling, as fuel is flowing from the nozzle into the tank, air being displaced by the rising fuel level flows through the rollover/float valve in the tank, into the vent hoses, then to the charcoal canister where hydrocarbons are captured for combustion during engine operation at the time of purge. The air being displaced by fuel entering the tank, after passing through the canister, escapes through the normally open vent valve, which is only closed during MFI-ECU controlled Evaporative System testing. Once the tank is full, the rollover/float valve (fig.1) closes, preventing fuel from entering the charcoal canister.

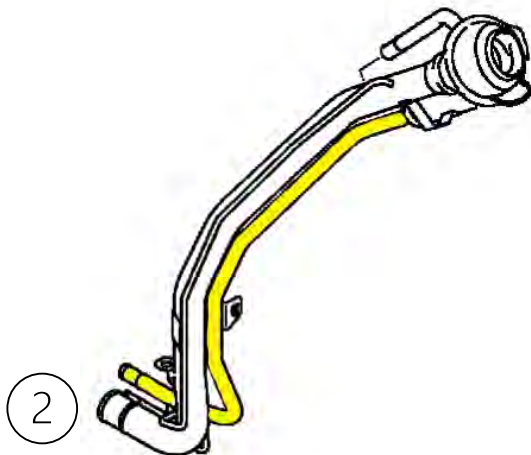
3

An additional hose referred to as a vent or signal hose (fig 2), allows some of the air to flow from either from the EVAP system or directly from the top of the tank (depending on the model), to the area just above the sensor tube on the filler nozzle (fig 3). Without this important component, fuel flow may not be smooth and may splash back at the nozzle sensor causing the filler nozzle to shut off.

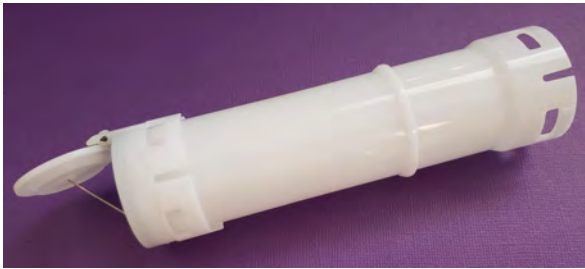
4

Once the tank is full and the float valve is closed, there is a tendency for fuel to rush up the filler neck causing a splash back effect more severe than what is required to shut the nozzle off. The point where the filler neck connects to the tank, is equipped with a short tube (located inside the tank) which incorporates a spring-loaded flap (fig 4) to stop the flow of fuel upwards.

In short, air is delivered to the area around the fuel nozzle to divert liquid away from the sensing tube on the fuel nozzle. Once fueling is complete, the air flow stops, and the smallest amount of liquid fuel is enough to shut off the nozzle. If air can't flow through the EVAP system, fuel can back up in the filler neck shutting off the nozzle. If air is unable to flow through the vent/sensor hose on the filler neck due to hose delamination or being clogged with debris, fuel may splash back against the sensor tube on the nozzle and shut it off.
