SERVICE ACTION

Global Service Action
Number: N955

Subject: MHEV Harness Clash	Publication No.: N955
	Model: Range Rover Sport (L1)
	Model Year: 2025
	Model: Range Rover (LK)
	Model Year: 2025
	Date of Issue: 12 December 2024
	Expiry Date: 31 December 2026

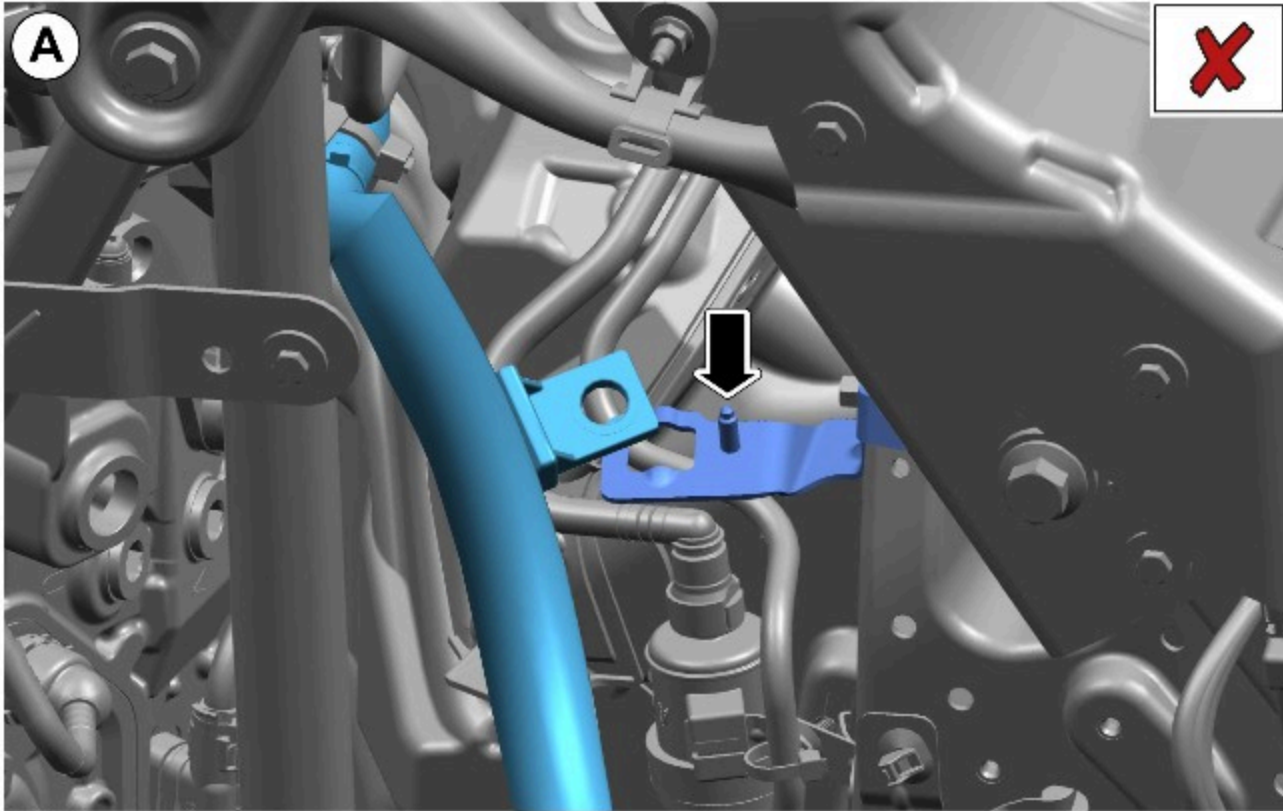
E374309

A quality concern has been identified where there may be a missing fixing on the Mild Hybrid Electric Vehicle (MHEV) battery harness which is away from design specification.

- If the [MHEV](#) harness bracket nut **IS** missing as shown in **illustration A** or **illustration B** with the **RED X**, continue to **step 3**.
- If the [MHEV](#) harness bracket nut **IS NOT** missing as shown in **illustration C** with the **GREEN ✓**, no further action is required. Continue to **step 4**.

3. Install the [MHEV](#) harness on the bracket.

- Install and tighten the nut.
- Torque: **9 Nm**
