992 Lightweight Rear Quarter Glass Panes Are Cracked

Advanced Technical Information

Bulletin #: 2435

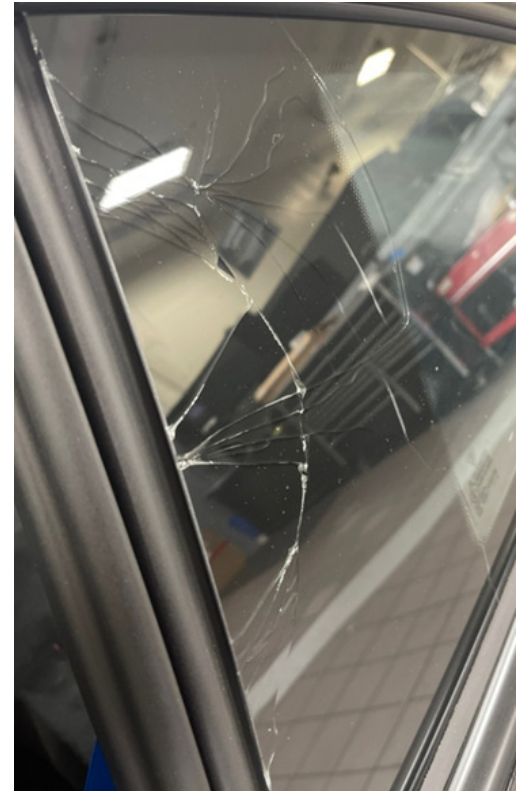
Figure 1

There are multiple causes for this condition. Generally, these causes relate to the amount of tension on the glass during and after the repair. The most common causes are:

- The quarter glass mounting nuts are over-torqued, increasing tension on the rear quarter glass.
- The door or door glass is misaligned. This can produce a collision between the door glass and the rear quarter glass or increase tension on the rear quarter glass.
- There is adhesive leakage on the body panel slightly reducing the geometry and increasing tension.
- There is an offset between the inner and outer body panels, changing the dimensions of the opening and increasing tension.
- The adjustable bolts are out of tolerance, which increases the tension on the glass.
- Customer behavior may also be a factor that causes cracks. The customer may inadvertently strike the glass with jewelry (including rings and watches) or allow his or her bodyweight to rest on the glass pane while exiting the vehicle.

Please replace the affected glass pane(s) as instructed in WM 647519 – *Removing and installing side window (Coupe)*.
