WRU2 – Replacing Over-the-Air (OTA) Control Unit (Workshop Campaign)

Model Line: **Taycan (Y1A/Y1B/Y1C)**

Model Year: **2025**

Concerns: **Over-the-Air (OTA) control unit**

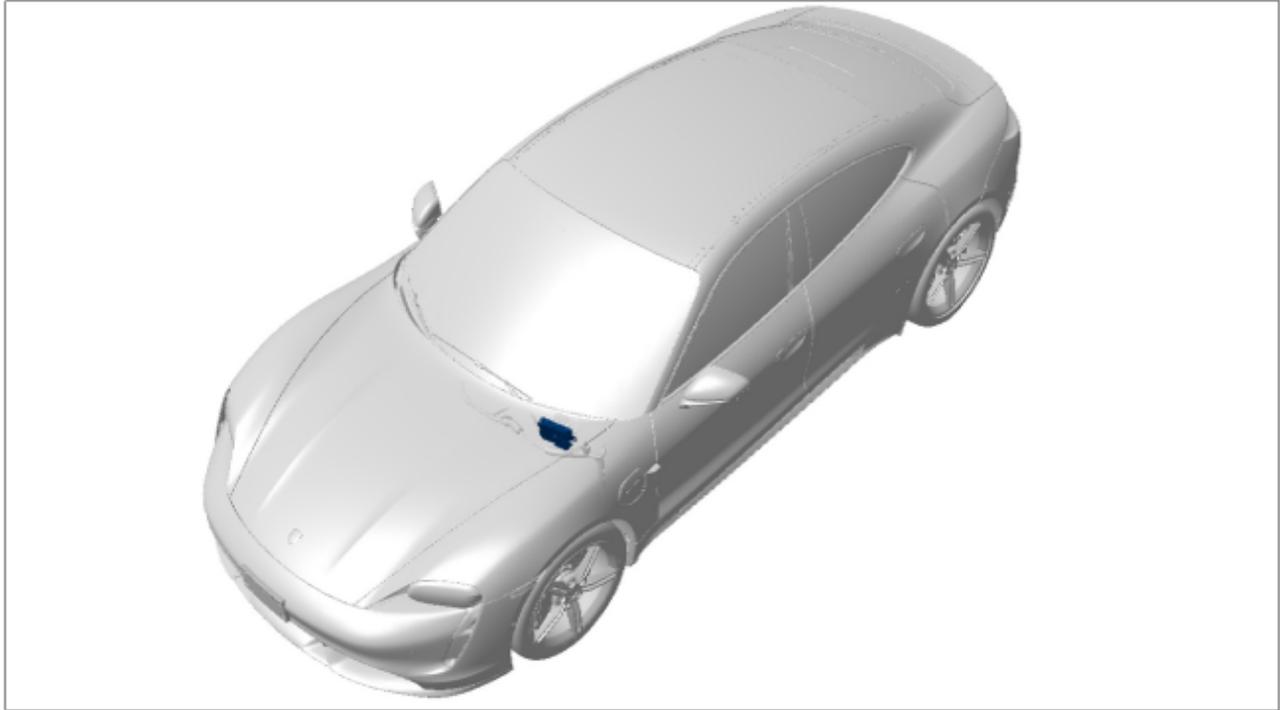
Cause: **There is a possibility that the bootloader programmed on the Over-the-Air (OTA) control unit does not meet the required specifications on the affected vehicles.**

As a result, Porsche Connect services/online services and the eCall system are not available. Lack of connectivity is indicated by a red LED in the roof console.

Installation position of Over-the-Air (OTA) control unit

Action: Replace the Over-the-Air (OTA) control unit.

- Work Procedure: 1 Remove the **previous** Over-the-Air (OTA) control unit and install a **new** Over-the-Air (OTA) control unit.
 ⇒ *Workshop Manual '919819 Remove and install over-the-air control unit'*
- 2 Perform commissioning of the **new** Over-the-Air (OTA) control unit.
 ⇒ *Workshop Manual '919855 Replacing over-the-air control unit'*
- 3 Enter the campaign in the Warranty and Maintenance Logbook.
