**WRE7 - Re-Programming Porsche Rear Seat Entertainment (Workshop Campaign)**

Model Line: **Panamera (971)**

Concerns: **Porsche Rear Seat Entertainment (M-no. 9WY)**

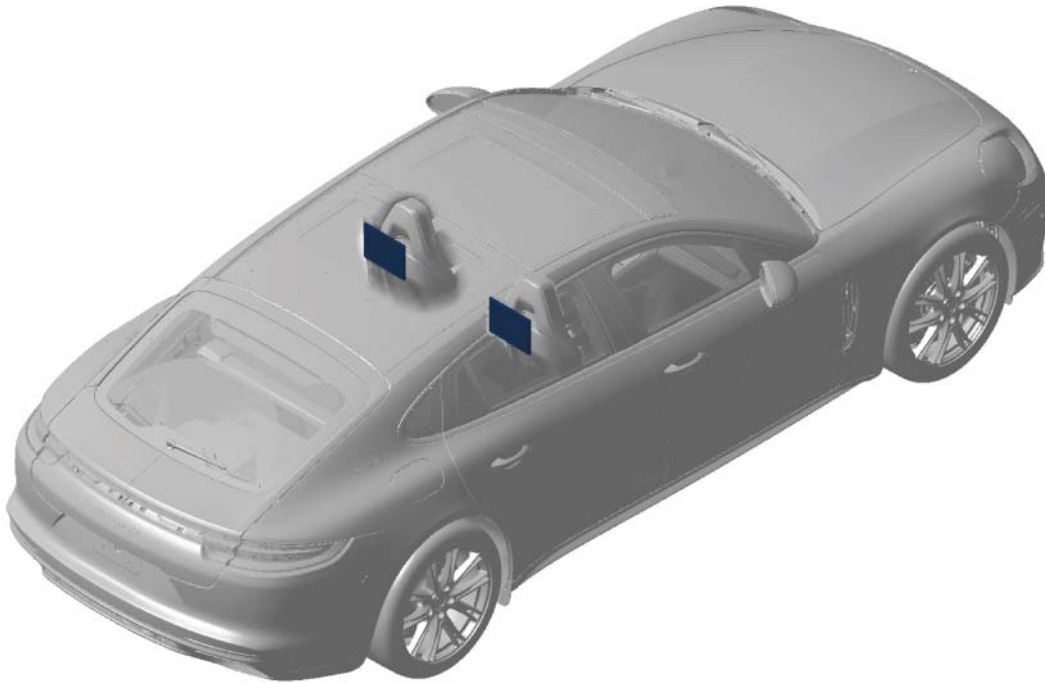
Cause: **On the affected vehicles with Porsche Rear Seat Entertainment (M-no. 9WY), there is the possibility that there will be repeated sleep-wake cycles in a short sequence due to the GSM service.**  
As a result, the maximum number of write cycles on the internal memory is exceeded and the Porsche Rear Seat Entertainment system can no longer be started.

*Installation position of display unit*

Action: Re-program Porsche Rear Seat Entertainment display unit with an updated data record.
