Y1A Y1B Y1C - Taycan Control for Plug and Charge is Greyed Out

Bulletin #: 2434

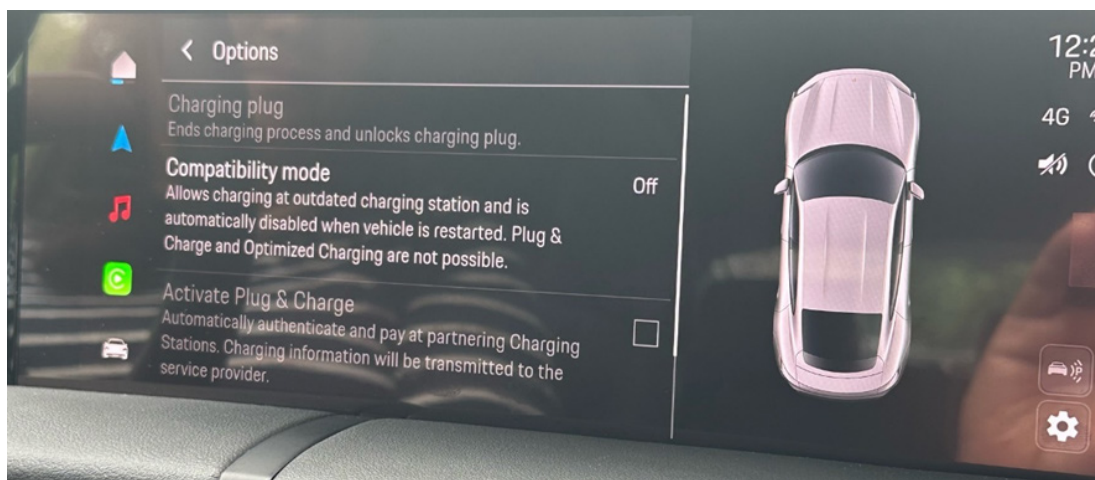
The customer or workshop finds the setting for Plug and Charge is greyed out and cannot be activated in the PCM Central Display Charging >> Options menu in the affected vehicles. (See Figure 1).

Figure 1: Activate Plug & Charge cannot be checked

The subject condition may exist in 11 kW On-Board Charger (OBC) software version 3015 and 3018. This is expected to be permanently addressed with OBC software version 3020.

- A. Perform at least one PCM Reset to Factory Settings via the *PCM Central Display Settings >> System Settings >> Reset to Factory Settings*.
 - a. In some cases, it may be necessary to perform the Reset to Factory Settings multiple times (2, 3, or 4 times) for the Reset to complete.

Check for PNC control in the PCM after performing Reset to Factory Settings. If the selection remains greyed out, proceed to B.
