GROUP	MODEL
ELE	2023-2024MY Telluride (ON) SX and SX Prestige
NUMBER	DATE
365	January 2025

TECHNICAL SERVICE BULLETIN

IDENTITY AUTHENTICATION UNIT (IAU) SEAT OPERATION LOGIC IMPROVEMENT

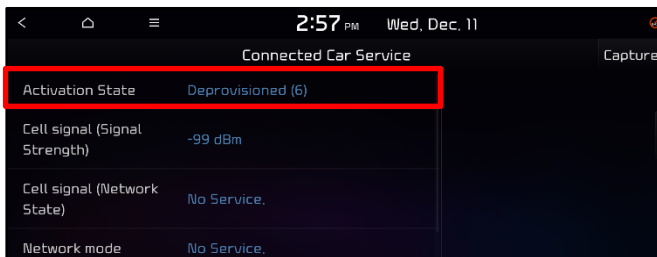
'Deprovisioned' Modem Status

Note: This issue may affect vehicles with head units in 'Deprovisioned' modem status and vehicles sold in Massachusetts.
