Service Bulletin

Bulletin No.: 23-NA-151

Subject: Hybrid/EV Battery Stability, High Priority DTCs, Potential Loss of Isolation, Vehicle Handling and Battery Pack Return Shipping Requirements

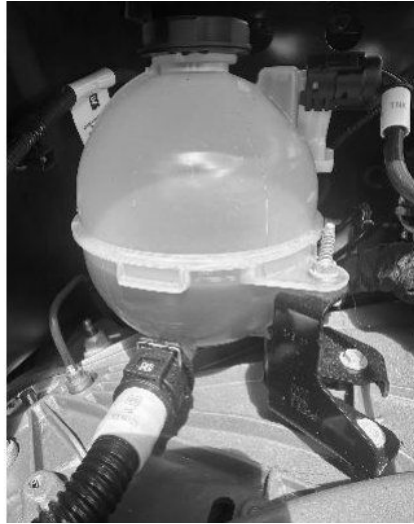
Figure 1 (Coolant Level - Passed)

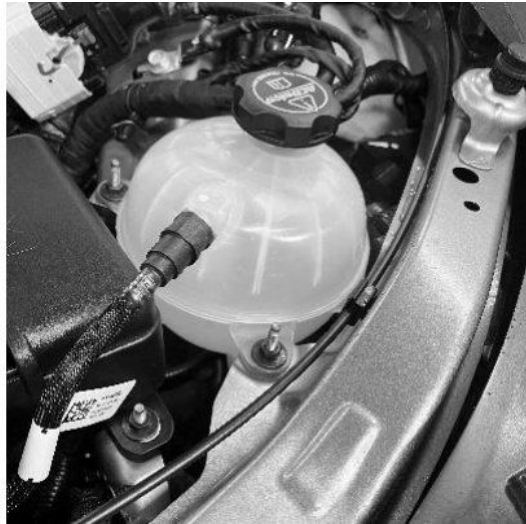
Danger: *DO NOT add coolant without first confirming the Lithium-Ion Hybrid/EV Battery Pack internal coolant passage can maintain proper vacuum and pressure. Adding coolant to the coolant system with an internal lithium-ion Hybrid/EV Battery Pack coolant leak may result in Fire, which could result in vehicle or component damage, and cause severe body injury or death.*

Figure 2 (Coolant Level - Failed)

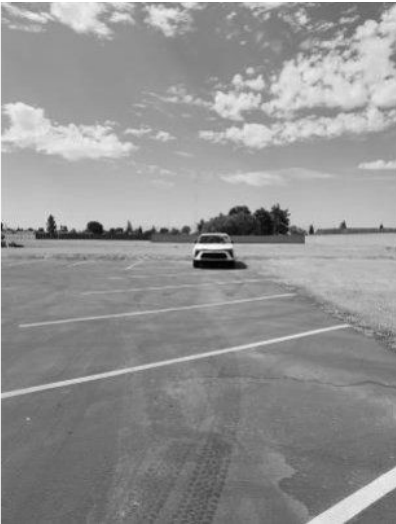
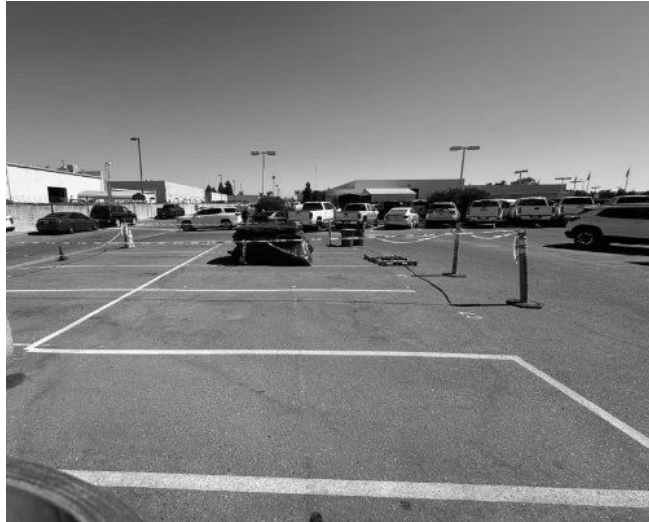
Figure 4 (Vehicle and Battery Pack Isolation – Passed)

7. Move the vehicle to a stable location outdoors: isolated and away from buildings, vehicles, and foot traffic while waiting direction to diagnose/repair. Recommended distance is 50 feet (15M). Document isolated location via photo (Fig 4 and 5). Refer to 'Neutral Service Mode' in electronic transmission range select service information if required.
8. Start a TAC case and upload all photos and your GDS2 session log per Document ID: 6385557 / PIP4902 and reference this bulletin. Additionally, provide any previous diagnosis work performed based on the DTC(s) set or inability to collect the data.

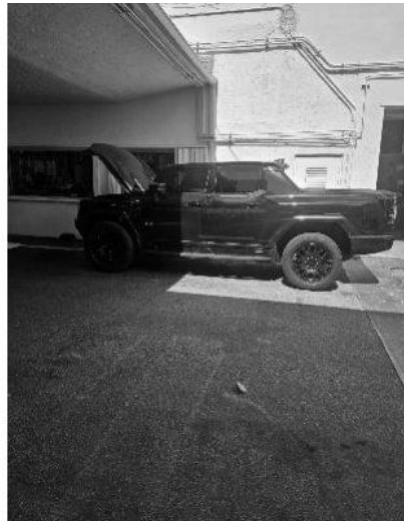
Figure 5 (Vehicle and Battery Pack Isolation – Failed)

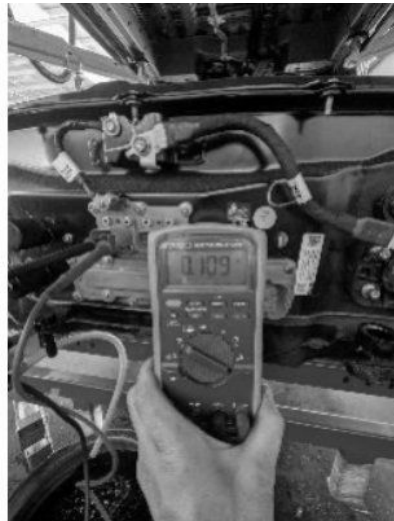
**Figure 6 (High Voltage Disable
Result < 3V)
Passed**

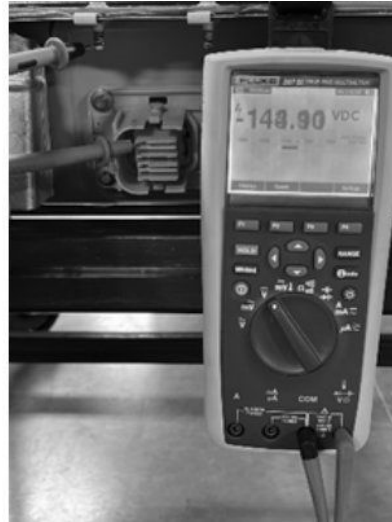
Note: If more than 3V is found, continue but contact TAC immediately upon completion.

**Figure 7 (High Voltage Disable
Result > 3V)
Failed**

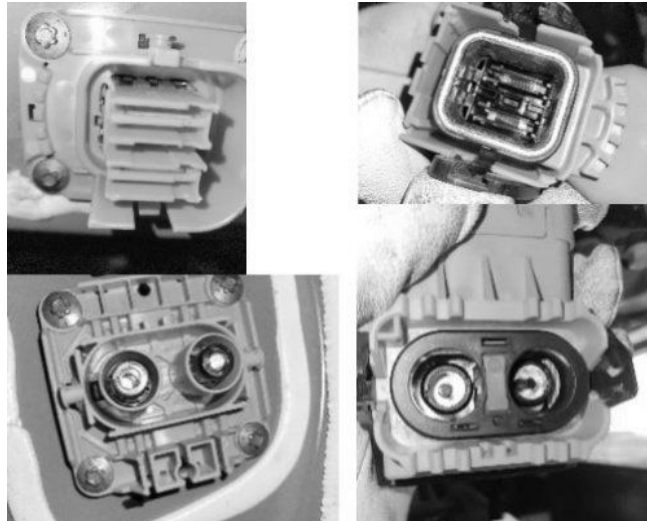
**Figure 8 (Battery Pack Connectors
– Passed)**

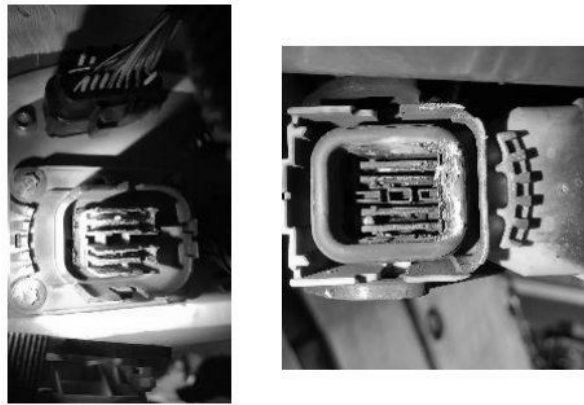
Note: If soot, corrosion or moisture is observed, continue but contact TAC immediately upon completion.

**Figure 9 Battery Pack Connectors
– Failed w/Heavy Soot)**

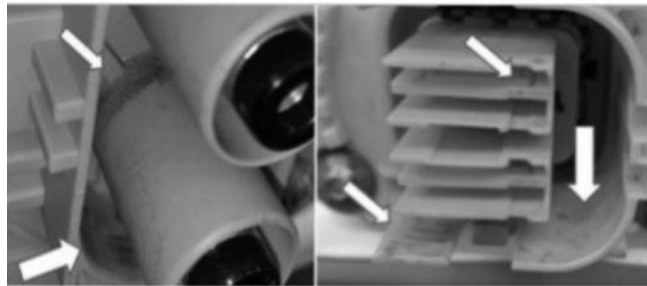
**Figure 10 (Battery Pack
Connectors – Failed w/Light Soot)**

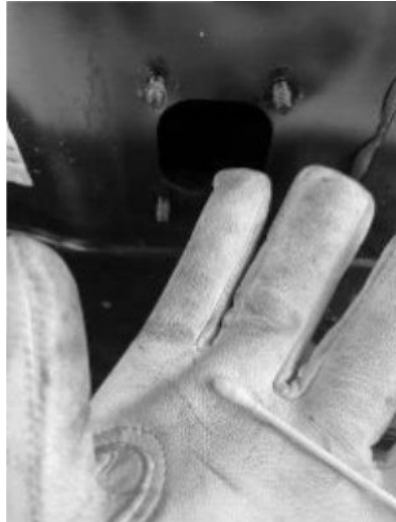
**Figure 11 (Battery Pack Swab Test
– Passed)**

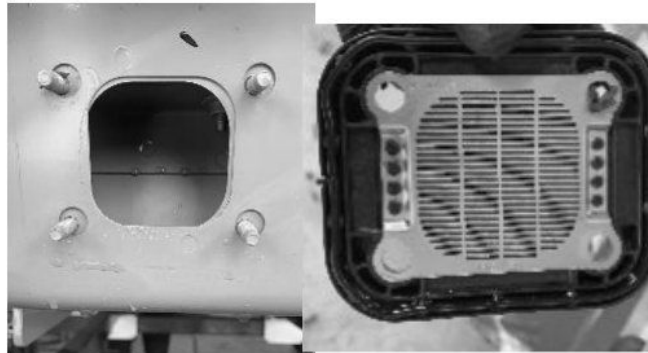
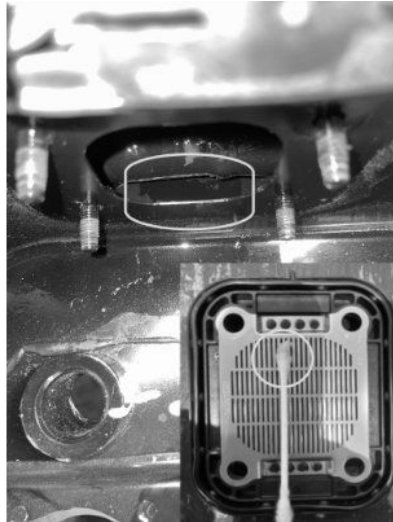
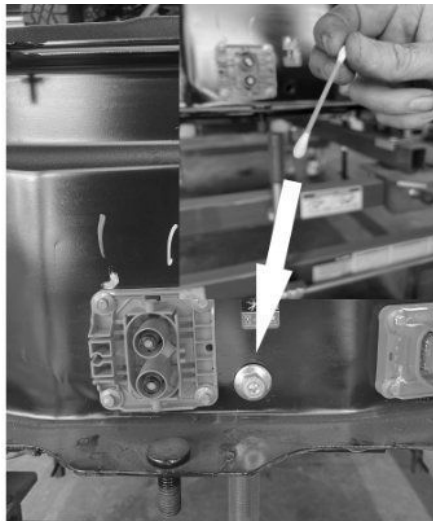
Note: If fluid/soot is observed, continue but contact TAC immediately upon completion.

**Figure 12 (Battery Pack Swab Test
– Failed)**

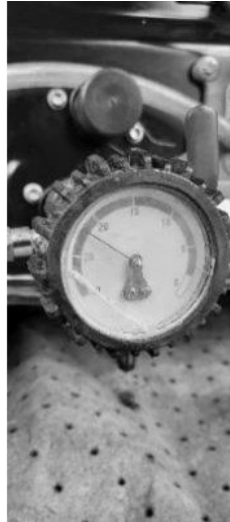
**Figure 13 (Coolant Passage
Vacuum Leak Test – Passed)**

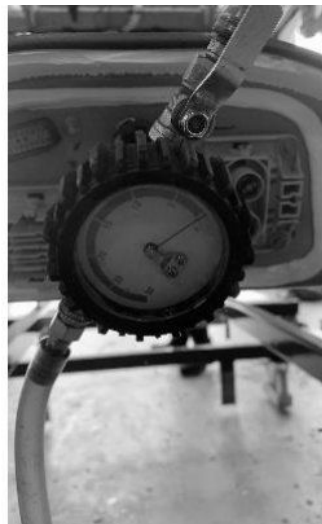
Note: If the High Voltage Battery coolant circuit does not hold vacuum, continue but contact TAC immediately upon completion.

**Figure 14 (Coolant Passage
Vacuum Leak Test – Failed)**

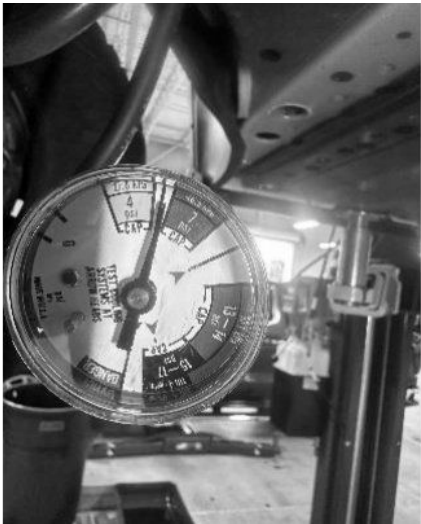
Figure 15 (Coolant Passage Pressure Leak Test – Passed)

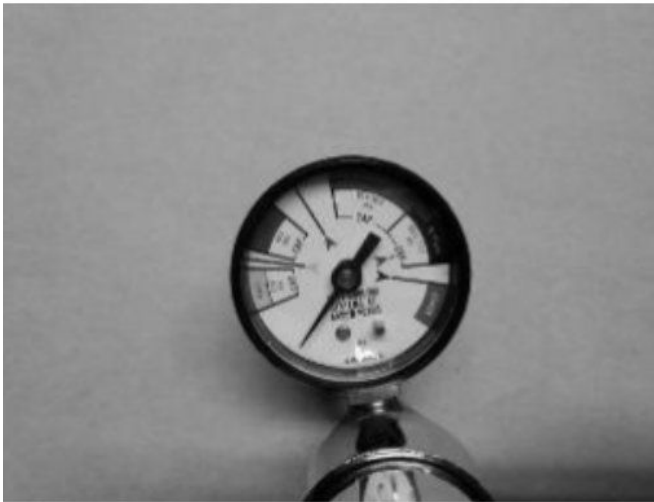
Note: If the High Voltage Battery coolant circuit does not hold pressure, continue but contact TAC immediately upon completion.

Figure 16 (Coolant Passage Pressure Leak Test – Failed)
