Abnormal Fluttering and/or Vibration Across Rear-Center Section of Hood

Section Exterior Panels/Trim

YEAR(S)	MODEL(S)	ADDITIONAL INFORMATION
2024	Grand Highlander, Grand Highlander HV

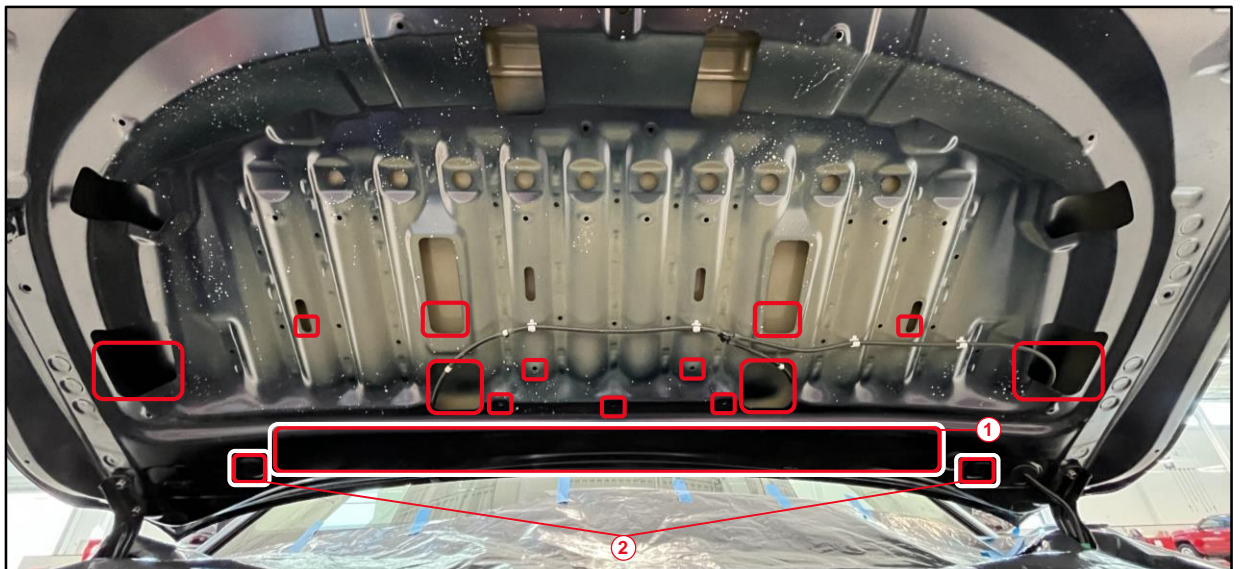
Figure 7. Example of Under the Hood

Cavities Used to Fill Foam
1	Fill Area Evenly As Possible

2	Holes Covered by Black Stickers
----------	---------------------------------

Fill cavities with expanding foam until the foam is touching both the inner and outer hood panels. The use of a borescope may be helpful to ensure foam expansion but is not required.

Black stickers covering some holes will need to be removed and replaced once the expanding foam has cured.
