Front Seat Creaking or Squeaking Noise

Service Category Vehicle Interior

Section Seat

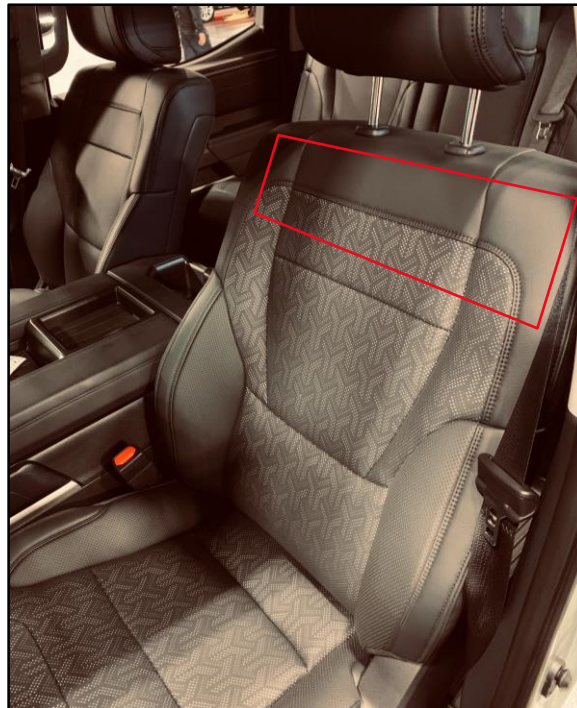
Some 2023 – 2024 model year Sequoia Hybrid, and 2022 – 2024 Tundra and Tundra Hybrid vehicles may exhibit a condition where the driver and/or front passenger seat back frame produces a creaking or squeaking noise when leaning back on it, or when pressing on the area shown in Figure 1. Follow the Repair Procedure in this bulletin to address this condition.

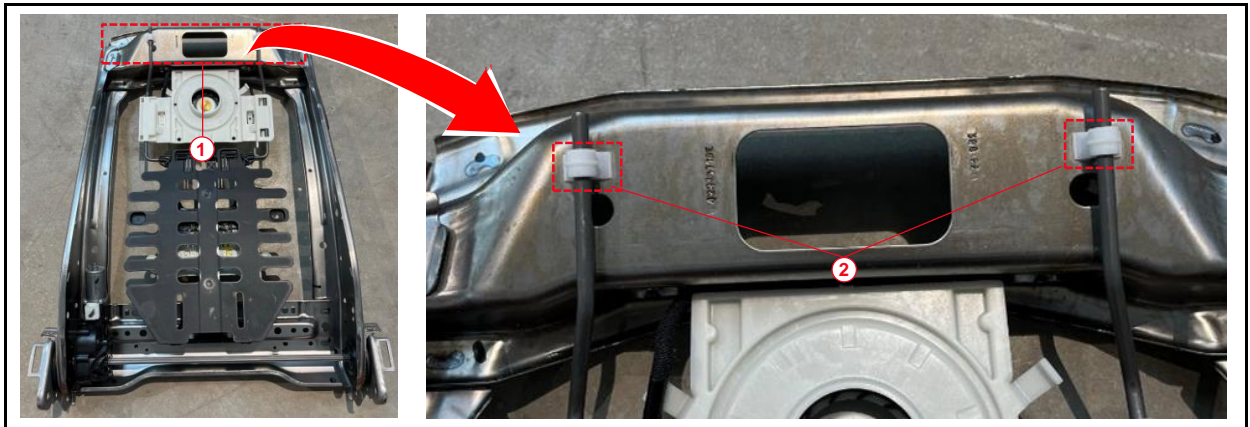
Figure 2. Seat Back Frame

| 1 | Location of the Hooks |
| 2 | Original Hooks |

- Loosen the hooks from the seat back frame and remove the hooks from the metal bars.

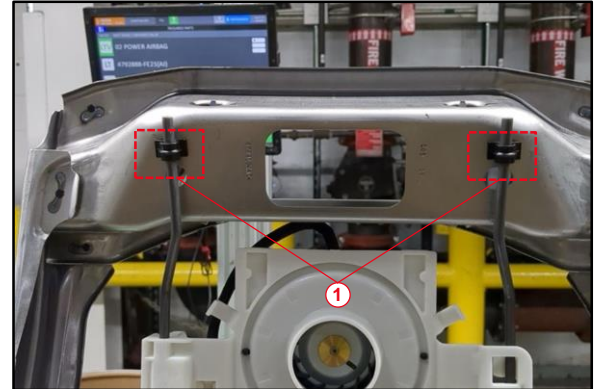
Figure 3. Seat Back Frame

| 1 | New Hooks Installed |

5. Attach the NEW hooks to the metal bars and install them to the seat's back frame.
