STAR ONLINE PUBLICATION

Case Number: S1408000384 Rev.G

Symptom/Vehicle Issue: Start Stop Charging Warning Lamp Illuminated On, Intelligent Battery Sensor (IBS) State of Charge (SOC) Inaccurate, Battery Charging Message, Presence of IBS related Diagnostic Trouble Codes (DTCs), or Battery Warning Lamp On

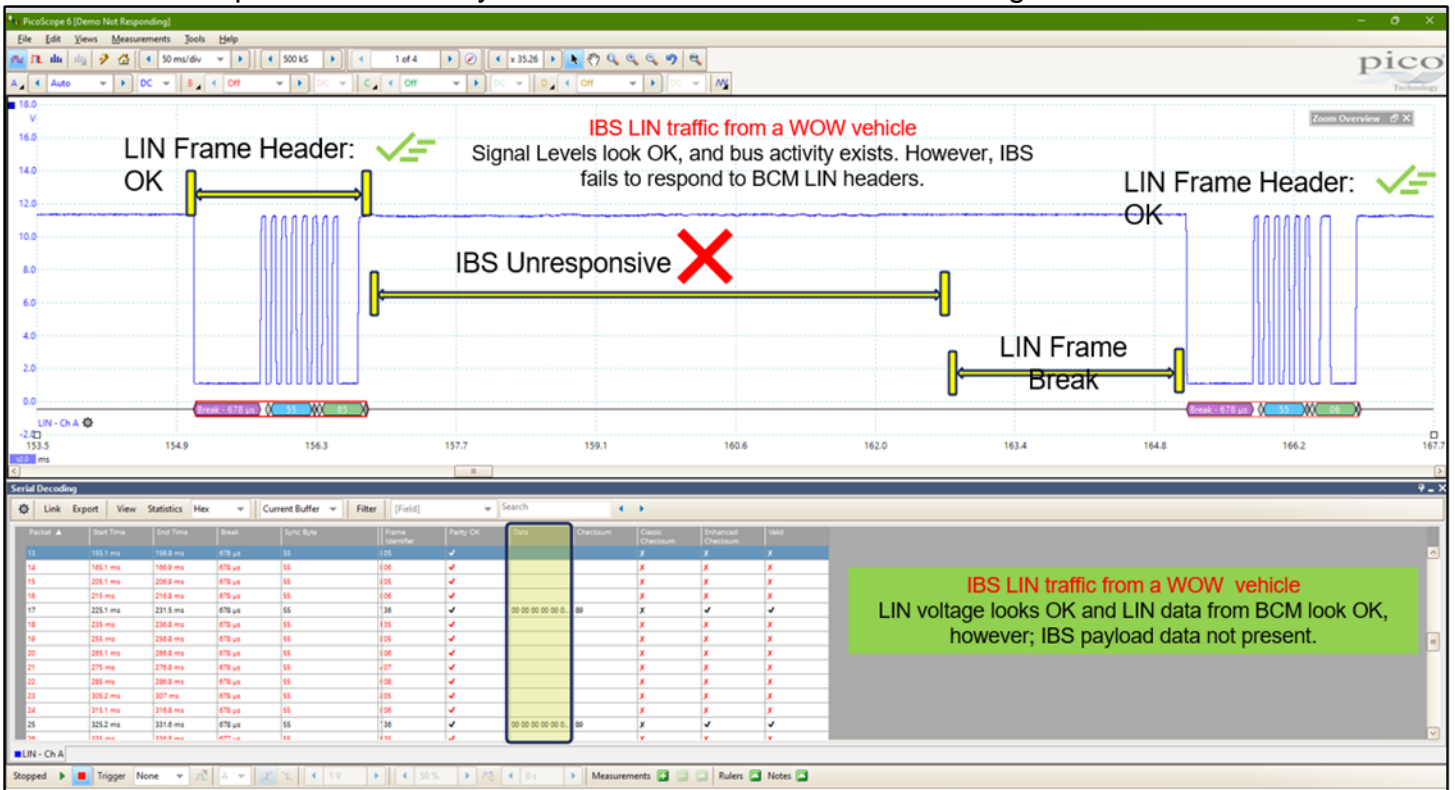
3. Verify power to IBS by back probing the IBS 2-way connector (pin 2, "RD" wire).
 - o If voltage is lower than 11.8V, follow normal procedures for low batteries.
4. Verify IBS feed fuse state. Replace the fuse if needed.
5. Verify LIN bus activity with Mopar scope.
 - o Config scope to LIN monitor if feasible.
 - o Replace the IBS only based confirmation from the LIN diagnostic.

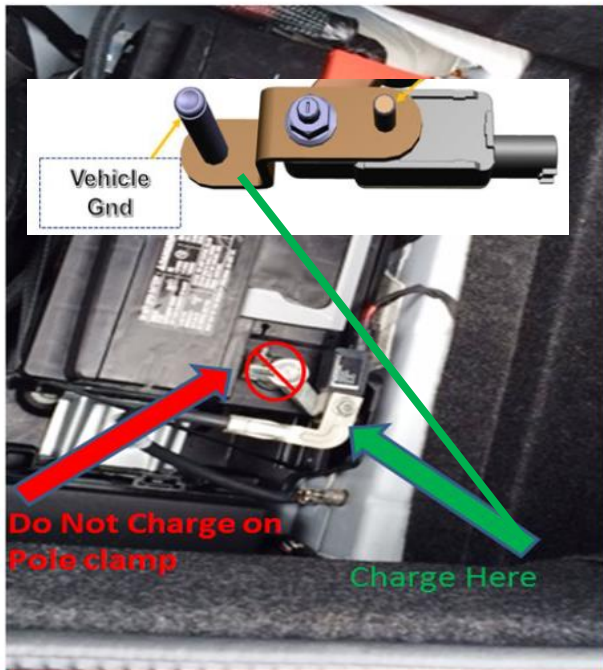
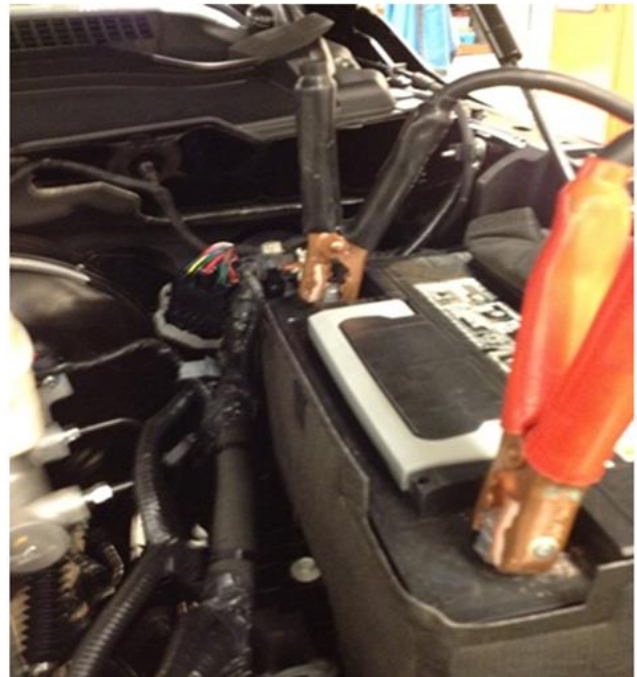
Improper IBS Charging

In-Vehicle systems is not an issue. Please note to charge through the IBS or tie negative clamp to Body/engine ground. Customers, Dealers, Mechanics, and Engineers usually want to place the negative clamp on the pole of the battery. This creates Blind charging. **“DO NOT BLIND CHARGE”** See below proper connections for charging.

Do not put Negative clamp on IBS Pole clamp

Do not remove IBS for charging

- IBS SOC adaptation is needed after charging the batteries.
- Note IBS will self-adapt in the next available quiescent state.
- A common misdiagnosis is Battery light illuminated. The IBS has NOTHING to do with this light. The battery Light is indicative of a “CHARGING SYSTEM and condition of the battery”

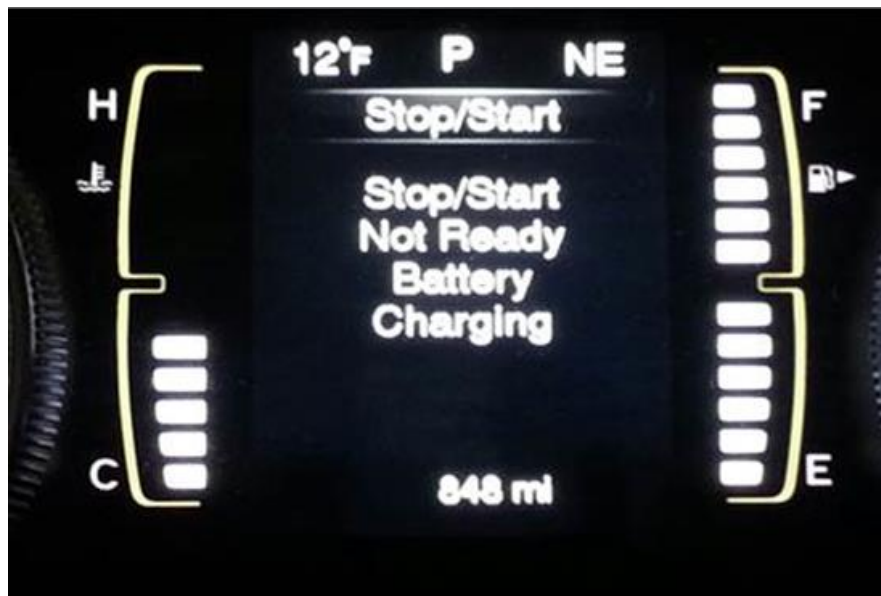
Example Display on a start stop vehicle.

ESS INOP can occur due to many factors not related to the IBS functionality. Moreover, ESS can get inhibited if battery SOC (state of charge) falls below the allowed SOC level. The SOC level varies depending on temperature since temperature affects the battery performance. The SOC state is monitored by the PCM and BCM. Battery temperature and SOC (State of charge are critical) see chart for [start stop engine on conditions](#).

- The IBS should only be replaced if a DTC for the IBS is active.
