STAR ONLINE PUBLICATION

Case Number: S2523000002

Symptom/Vehicle Issue: Outside Exterior Mirror Power Extend And/Or Retract Is Not Fully Functional.

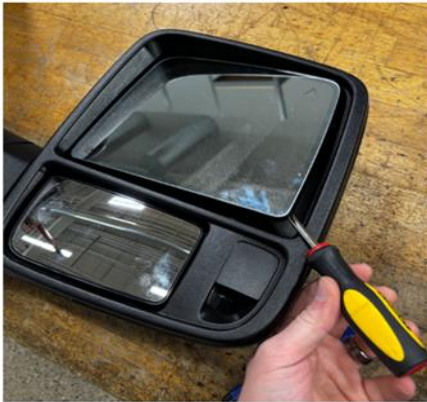
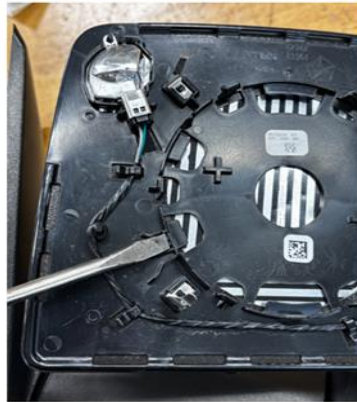
- 1.) Remove the main glass. Wiring attached to the glass does not need to be disconnected.

Use a flat blade screwdriver to remove the glass.

Placing the head of the driver in between the glass backplate and the glass actuator in the service ramp on the lower outboard corner aids in removal.

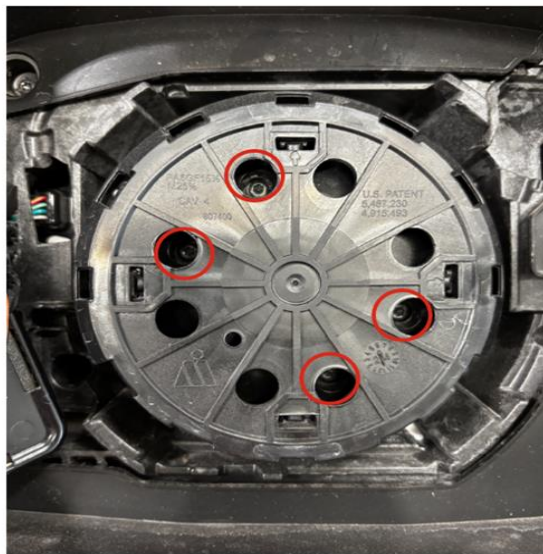
- 2.) Remove (4) screws holding the glass actuator in position with a T-15 torx driver.

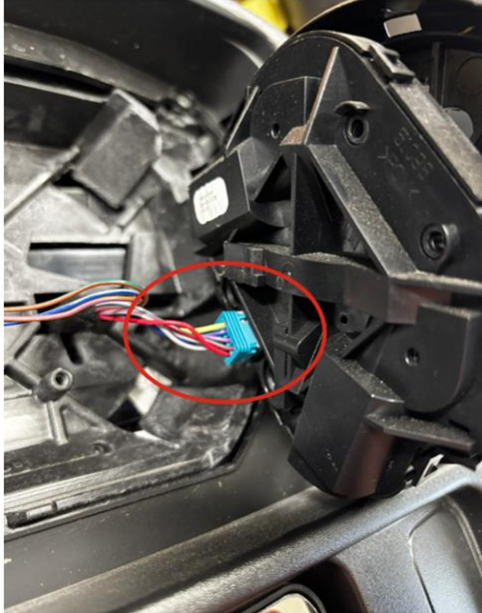
- 3.) Remove and unplug the main glass actuator.

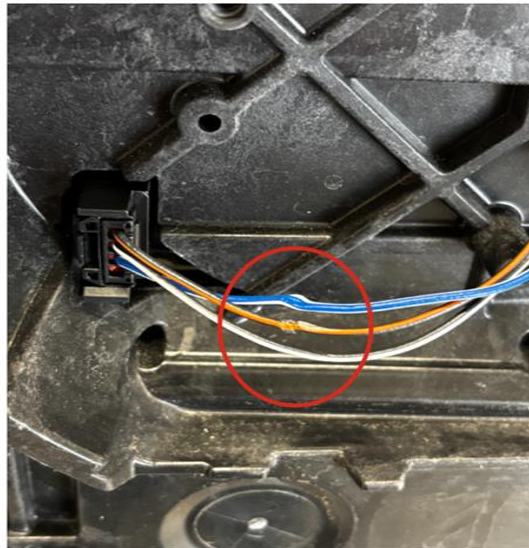
Discussion: The power extend/retract tow mirrors contain microswitches (sales code: -LEM) or potentiometers (sales code: +LEM) that provide feedback to the vehicle about the location of the mirror head. The wires for these switches/potentiometers can be pinched between the main glass actuator and the bracket the glass actuator mounts to during the supplier's assembly process. When these wires are pinched the above noted issues may be observed.

4.) Inspect for pinched wires to the extend/retract module.
