Noticeable Play in Height Adjustment of Steering Column

| Topic number | LI46.15-P-078766 |
| Function group | 46.15 - Steering column adjustment |
| Validity | Model 167, 206, 214, 223, 236, 254, 294, 295, 296, 297, 232, 192, 465, 463 |

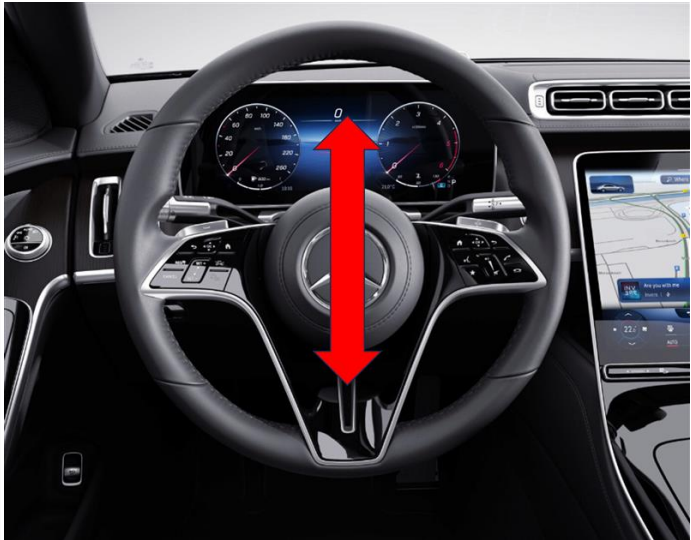
| Attachments | |
|---|---|
| Direction of Play.jpg | Direction of height adjustment |

Play noticeable in the height adjustment of the steering column. See arrow direction in attached pictures.

Slipped thrust bearing ring on the height adjustment.

Install repair kit for height adjustment of the steering column.
