Service Bulletin

Bulletin No.: 24-NA-206

Subject: Radio Stays on for Approximately One Minute After Vehicle is Shut Off and Door is Opened

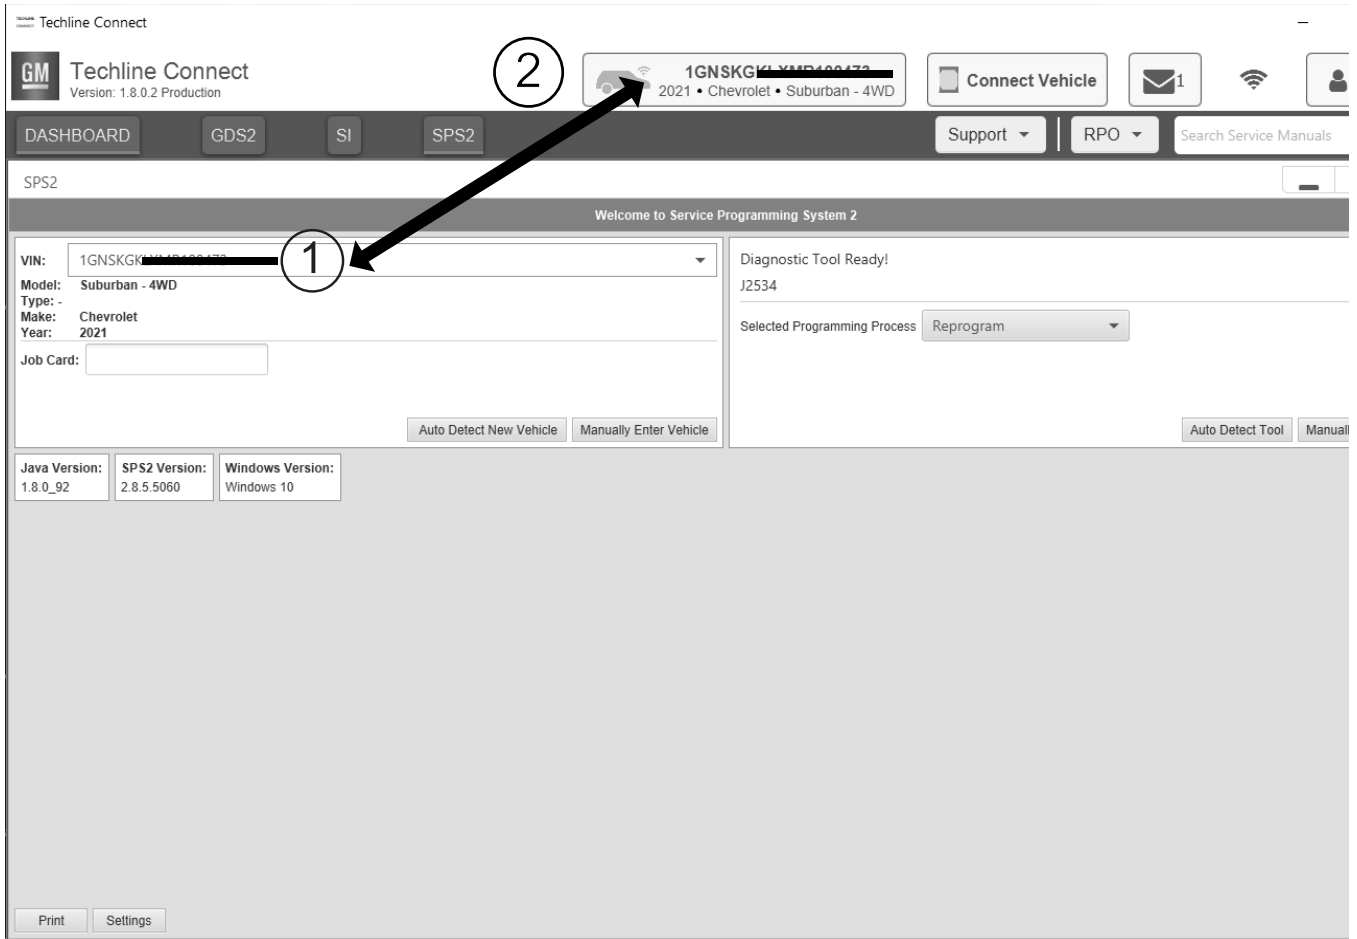
5743643

Caution: Be sure the VIN selected in the drop down menu (1) is the same as the vehicle connected (2) before beginning programming.
