Service Bulletin

Bulletin No.: PIE0809

Subject: Engineering Information - (EI Lite) (Picture Only) Rattle Type Noise Coming from the Exhaust System at Idle, Cold Startup and/or Operating Temperature at Certain Driving Speed

Brand:	Model:	Model Year:		Breakpoint:		Engine:	Transmission:
		from	to	from	to		
Cadillac	Escalade Models	2024	2025	—	—	Equipped with 6.2L (RPO L87)	—

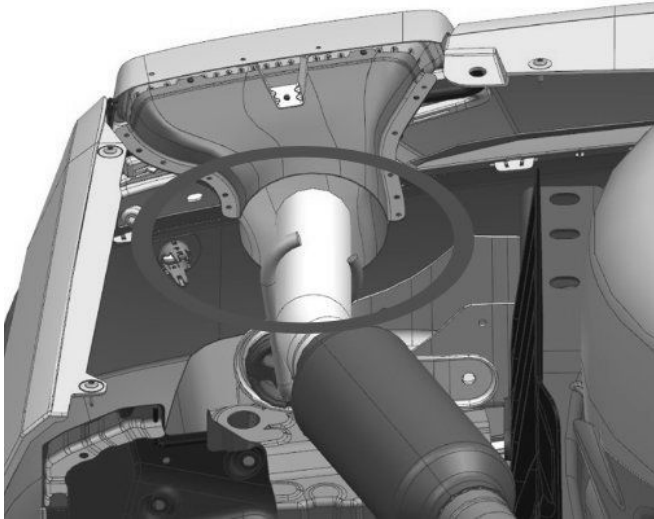
6783156

1. Take clear close-up pictures of the issue areas, as shown in the pictures above.
