Service Bulletin

Bulletin No.: 22-NA-249

Subject: Add-on Accessories Intermittently Lose Power

Brand:	Model:	Model Year:		VIN:		Engine:	Transmission:
		from	to	from	to		
Chevrolet	Tahoe	2021	2023

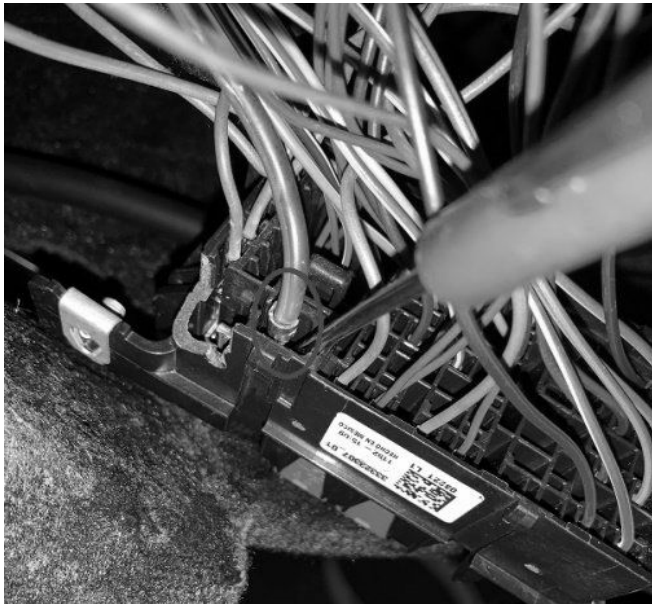
<p style="text-align: right;">6214193</p> <p>This condition may be caused by poor terminal tension at pin 36 at the X51AX connector.</p> <ul style="list-style-type: none"> - Battery power circuit 2742 intermittently opens due to a poor terminal pin grip to the bus bar relay center terminal.
Correction	If the terminal has been found to be loose in the connector, replace the terminal.

Refer to *Wire to Wire Repair*.
