# KARMA Technical Service Bulletin

TB-25-76-01

MODEL: Karma Revero GT and GTS, GS-6 and 2025 Karma Revero

## TITLE: Front Door Glass Fitment Inspection and Adjustment

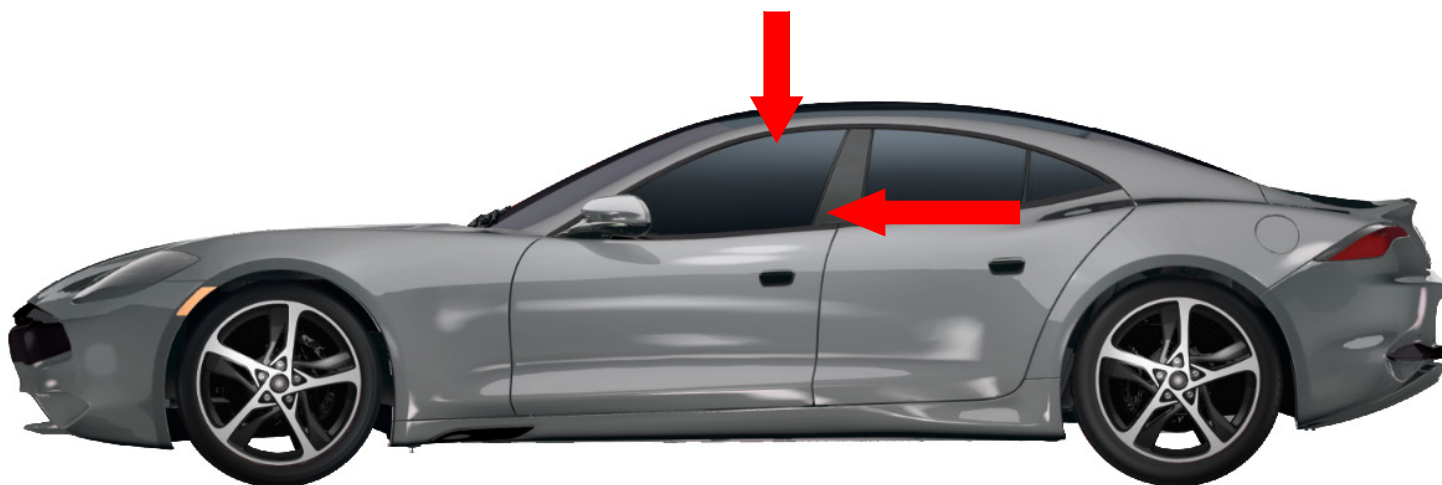
fig 1

The front door glass may not sit flush at the DLO and B-pillar location. The following procedure is to highlight the possible adjustments to correct this concern (fig 1).

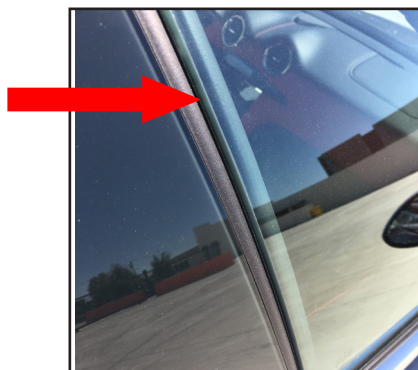
1. Verify condition of window glass, it must sit flush against the seals on the body when in the full up position and the door closed. The gap to appliqué should be 10 to 11.5mm and parallel along the glass edge.

Adjustment requires the glass clamp screws to be loosened, glass adjusted and re-tightened to 10Nm.

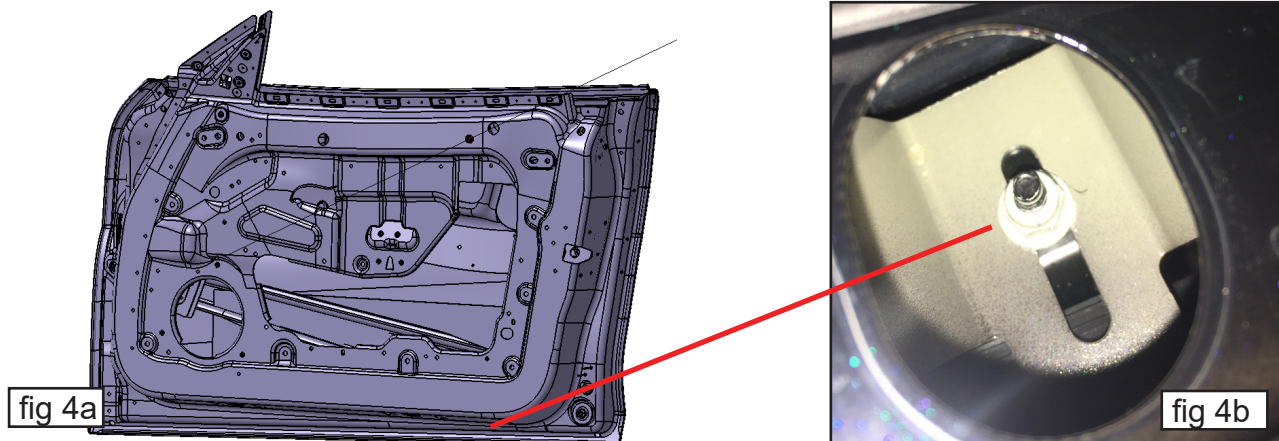
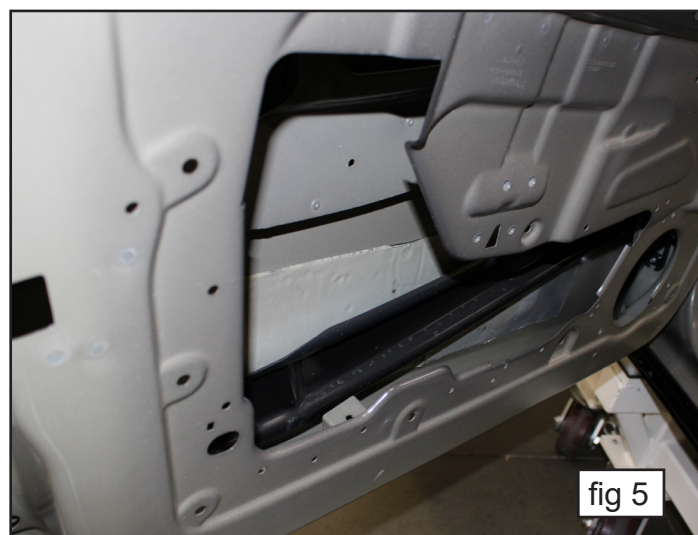
Shown here is a door without regulator or harnesses to highlight the interior parts (fig 5).  
There should be no rattles when the door is closed or shut with more force than is required with the glass up and glass down.

- 4) Adjust rear regulator mount, outboard as far as required to ensure proper glass alignment (fig 4a, 4b). Maintain clearance from the side impact bar, to avoid any interference (contact) or rattles.

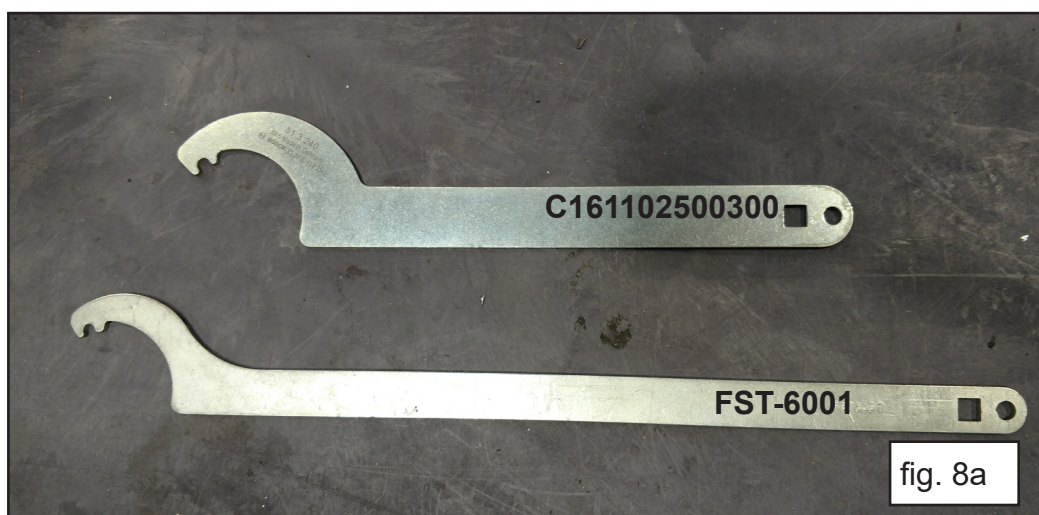
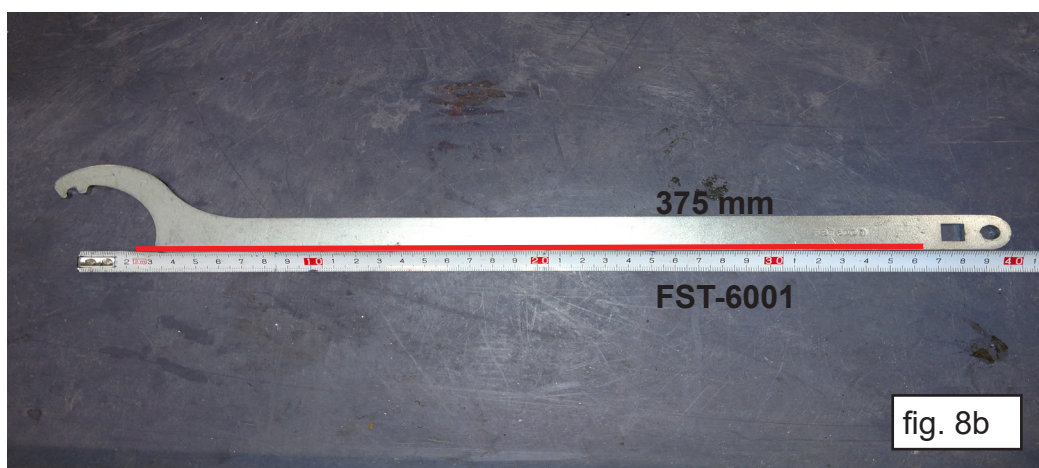
If you have an old style window spanner with the “FST-6001” marking this is longer than specification.

Please note the size difference of the two spanners the correct C161102500300 is the shorter correct tool (fig 8a, 8b).

Torque for the side clamp which should be at **5.0 Nm** as shown (fig 7b, 7c respectively)  
the fixed glass clamp torque is **4.1 Nm**.

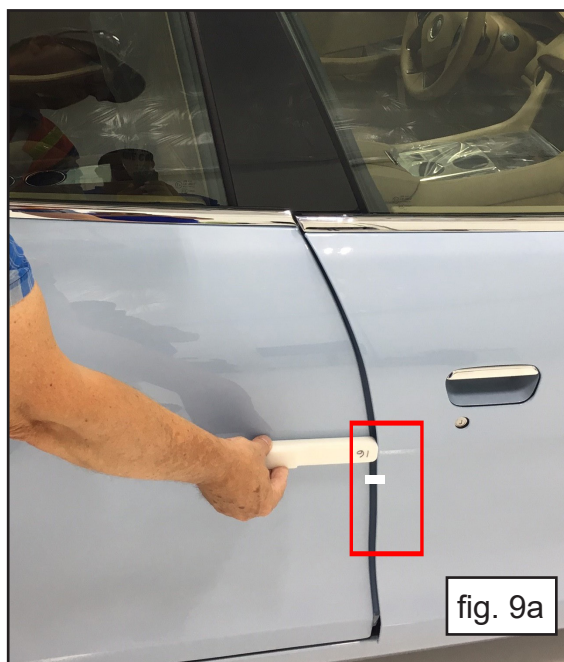
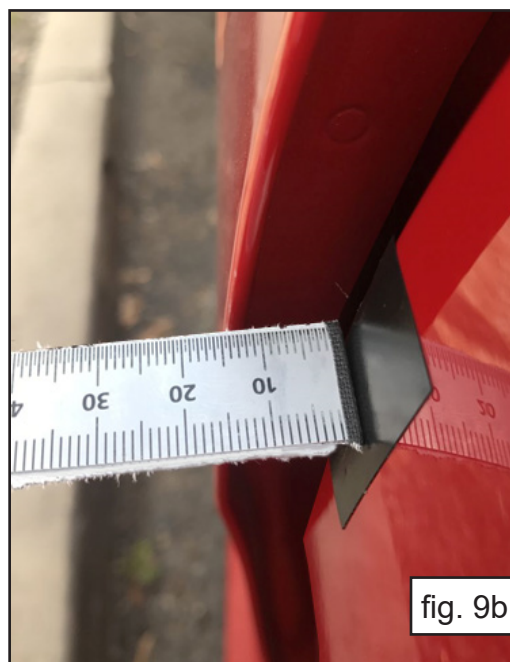
- 6) To verify the correction press the glass against the seal as shown (fig 9a)
- Door should be closed, but not shut, on the 2nd latch before closing
  - apply pressure to the rear corner of the front window and measure door to body gap this is expected to be **12-16mm** (fig 9b) check the indicated areas for with the door fully closed, to inspect and verify the correct gaps as well in fig 10.

If all available adjustments do not solve the concern – create a TSS case, for instructions on how to proceed.

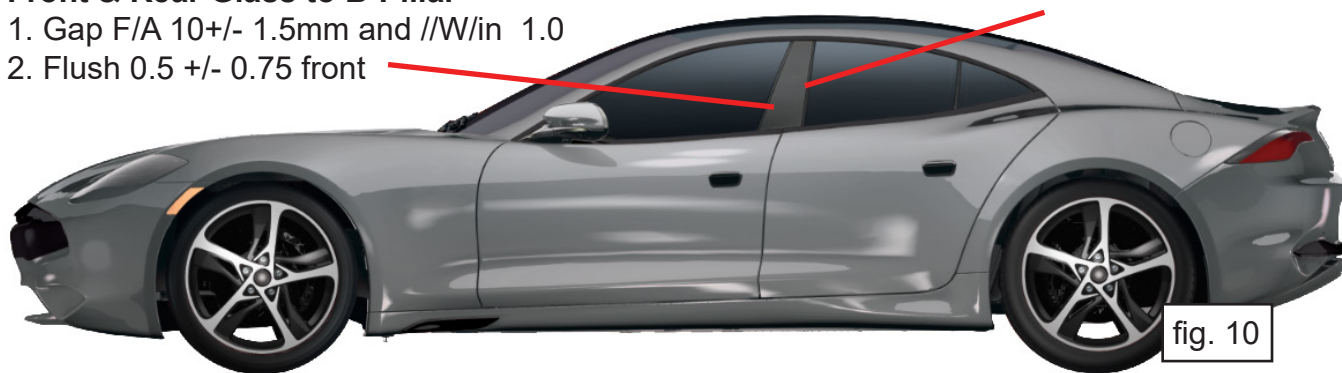
### Front & Rear Glass to B-Pillar

1. Gap F/A 10+/- 1.5mm and I/W/in 1.0
2. Flush 0.5 +/- 0.75 front

3. Flush -0.5mm +/- 0.5mm rear
