# Service Bulletin

Bulletin No.: 23-NA-156

**Subject: Information on Automatic Transmission Production Running Changes**

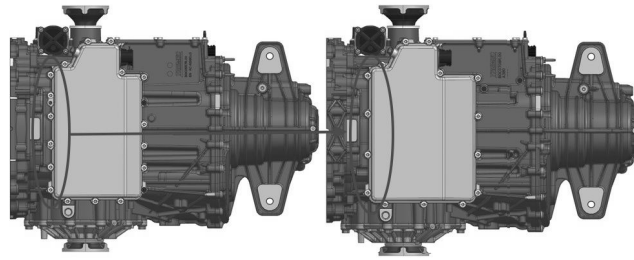
6420769

DIE 2 and DIE 3 transmission sump pans are not interchangeable and can be identified by the number of bolts in the leading edge towards the engine. The shape of the pan is noticeably different in shape, and the DIE 3 pan does not have studs to secure the harness.

To identify a new DIE 3 transmission easily, the new DIE 3 only has 4 fasteners along the front edge of the sump pan, where the old DIE 2 transmission has 6 fasteners along the front edge of the sump pan. Refer to the graphic above.

The additional 1.89 L (2 quarts) of transmission fluid (Track Fill) is not required in any DIE 3 transmissions, nor is it recommended for any DIE 2 transmissions in vehicles that are not RPO Z51 equipped because track use is not recommended for these vehicles. In the future, be aware that replacement service transmissions will migrate to the updated design for older model year vehicles. This change will require additional parts to be ordered to complete the replacement. Always verify what design transmission is in the vehicle prior to repairs.
