STAR ONLINE PUBLICATION

Case Number: S2408000063 Rev. C

Symptom/Vehicle Issue: Service Hybrid Electric Vehicle System Warning Message And Light Are Displayed. B273C-00 - Digital Crash Input Set In HCP

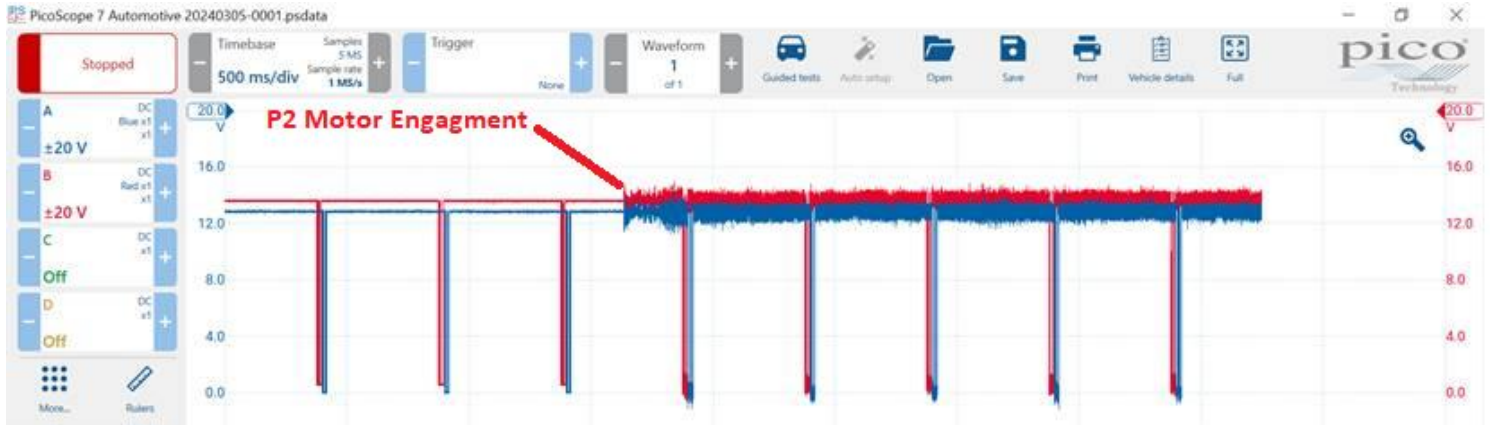
This issue may be caused by Electromagnetic Interference (EMI) from the High Voltage (HV) P2 Motor and associated HV harnesses which can transfer inductive voltage/electric noise onto the R41 - Airbag Deployment Signal and R414 - Airbag Deployment Signal 2 circuits. This inductive voltage/electric noise corrupts the health status signal and causes the B273C-00 – Digital Crash Input DTC to set.

Diagnosis: Connect an oscilloscope such as the Mopar PicoScope to the R41 and R414 circuits. When the P2 motor engages and begins operating, look for a distinctive change in the voltage pattern which would confirm the presence of induction voltage/ electrical noise, See Fig. 1. Some EMI on these circuits is expected during normal operation; however, some vehicles will exhibit more than others. If the electric noise is beyond the acceptable threshold, B273C-00 – Digital Crash Input will set in the HCP almost immediately after the noise is detected on the oscilloscope.

Fig. 1 :Electrical Noise on R41 and R414 Circuit After P2 Motor Engagement

Repair: As stated, some EMI is normal and will be observed on all vehicles and will not induce any faults. However, if B273C-00 only becomes Active when electrical noise is detected on R41 and R414 with an Oscilloscope. Excessive EMI on these circuits should be considered the root cause.

A HCP, AHCP and PCM software update and wiring harness repair is expected to be released in the form of a TSB/RSU mid-late Q1 2025. This software will increase the HCPs ability to detect a valid Digital Crash Input health signal when excessive EMI is present. The wiring harness repair will help eliminate excessive EMI.

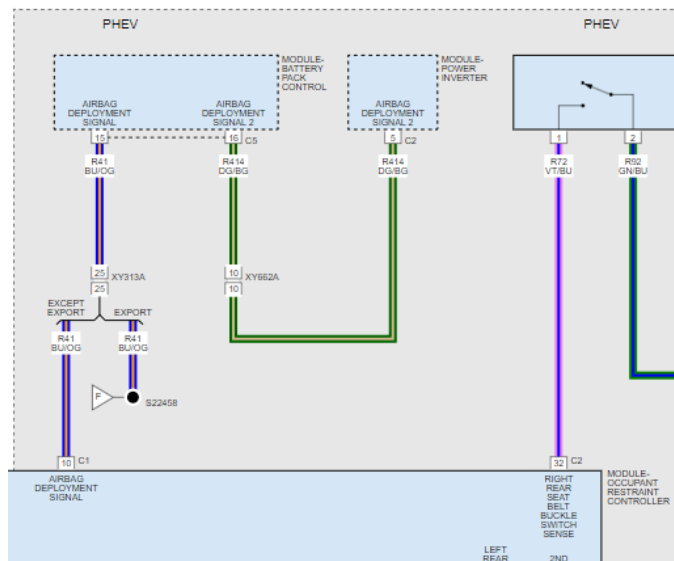
Fig 2: Airbag Deployment Signal Circuits (R41 and R414)
