Service Bulletin

Bulletin No.: 24-NA-028

Subject: Power Tonneau Cover Diagnostic Tips

Brand:	Model:	Model Year:		VIN:		Engine:	Transmission:
		from	to	from	to		
GMC	HUMMER EV Pickup	2022	2025	-	-	All	All

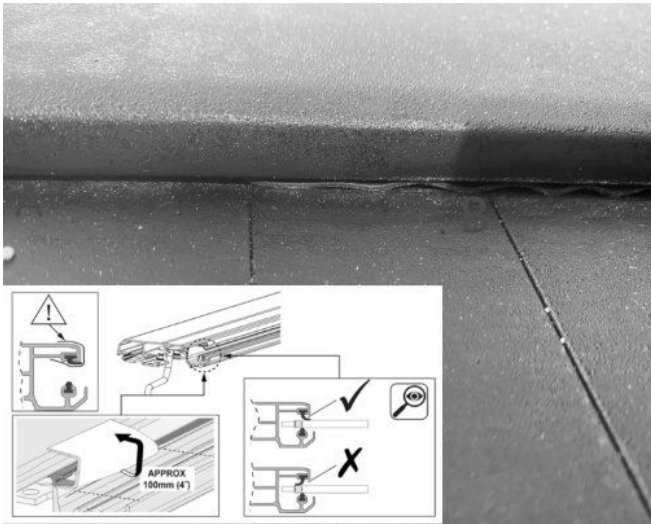
6544195

- Links to installation videos can be found in SI DOC ID 6152455, Pickup Box Cover Package Installation (Power Tonneau Cover).
- Always disconnect the 12v battery during installation. Failure to disconnect the 12V can lead to a blown fuse or module logic lockup.
- Care must be observed with all wires. Poor wiring can lead to shorts in the system.
 - Avoid any exposed or unsealed wires after splicing to the vehicle.
 - All connectors are securely locked in place.
 - Use caution during tonneau cover positioning to avoid pinched wires.
- Use tape to hold the top lip seal of the side rail during the installation of the side rail to the canister. Folded over side rail lip seal will cause the system to go into an unwanted anti-pinch mode.

Note: The above illustration shows what happens when the lip seal is under the cover during installation (A). The lip seal (B) is wavy due to incorrect assembly. The seal must be on top of the cover, not the cover. This will cause binding resulting in anti-pinch mode activation.

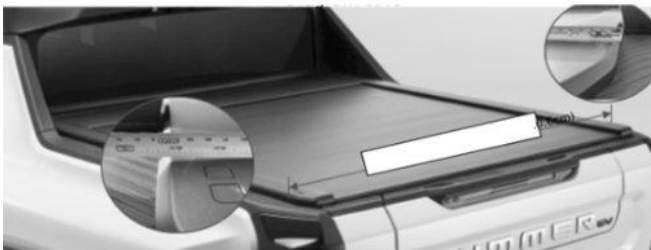
6540966

Note: During initial installation on a flat surface or protected table, tape back the seal surfaces on the front 4in. (100mm) of each rail using masking tape, as shown. This will protect them from damage during install.

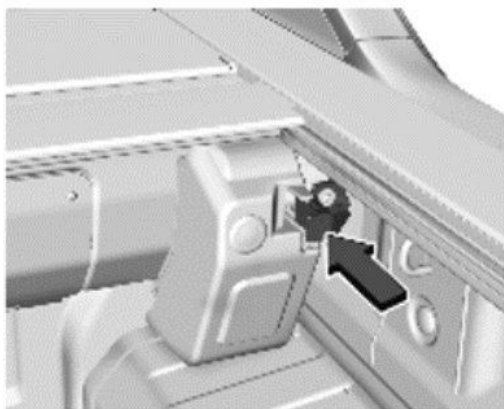
6540967

- Begin by manually sliding the cover in both directions. Pressing the clutch button on the motor allows for the tonneau cover to slide freely. Do this to aid with inspecting for binding. The clutch button should be checked to be fully extended prior to calibration/operation.

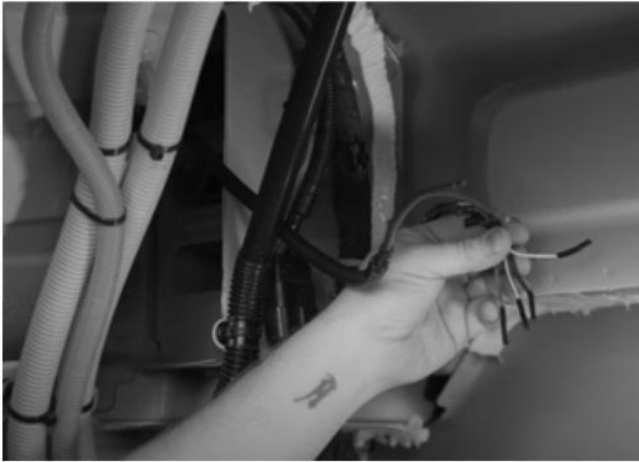
6540970

- Inspect the motor for any leakage. If any visible brown substance is found, replace the motor p/n 85607637.
- Check for power and ground at the X1 connector located at the power tonneau cover control module. Refer to SI DOC 6012295. If necessary, inspect the 4 wires connected to the main body wire harness under the left rear wheel well. Poorly installed and sealed splice connectors have been discovered and will cause electrical issues.

Showing the location of 4 wires in the main body wire harness that must be connected to the power tonneau cover asm. Inspect the wire-to-wire splice connectors for proper sealing and crimping.
