# Service Bulletin

Bulletin No.: 24-NA-084

**Subject: Radio Software Version 169.3**

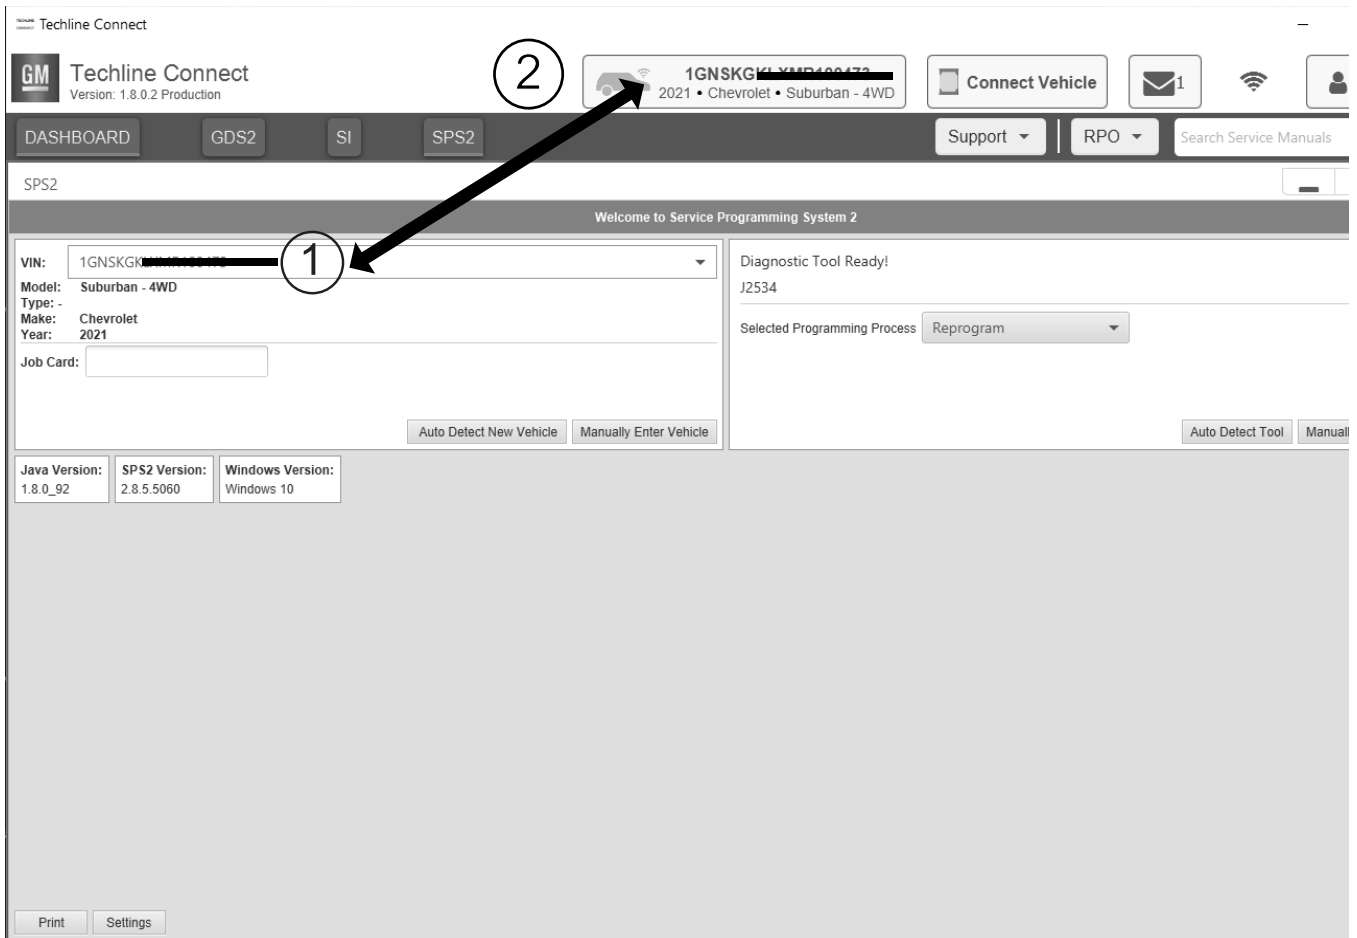
5743643

**Caution:** Be sure the VIN selected in the drop down menu (1) is the same as the vehicle connected (2) before beginning programming.

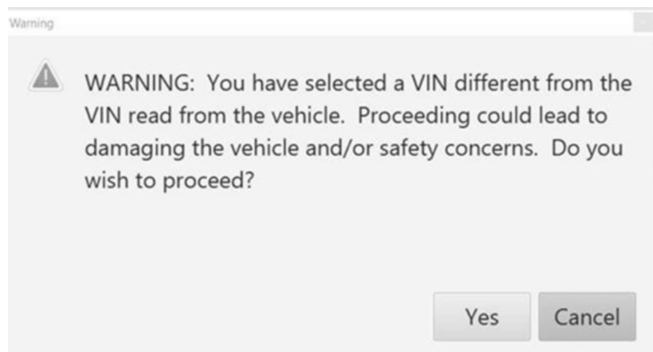
5877000

**Important:** If the vehicle VIN DOES NOT match, the message below will be shown.
