Service Bulletin

Bulletin No.: 24-NA-271

Subject: C103D.28 Set Current, Update Software K19 - Suspension Control Module

Brand:	Model:	Model Year:		VIN:		Engine:	Transmission:
		from	to	from	to		
Buick	Enclave	2025	2025

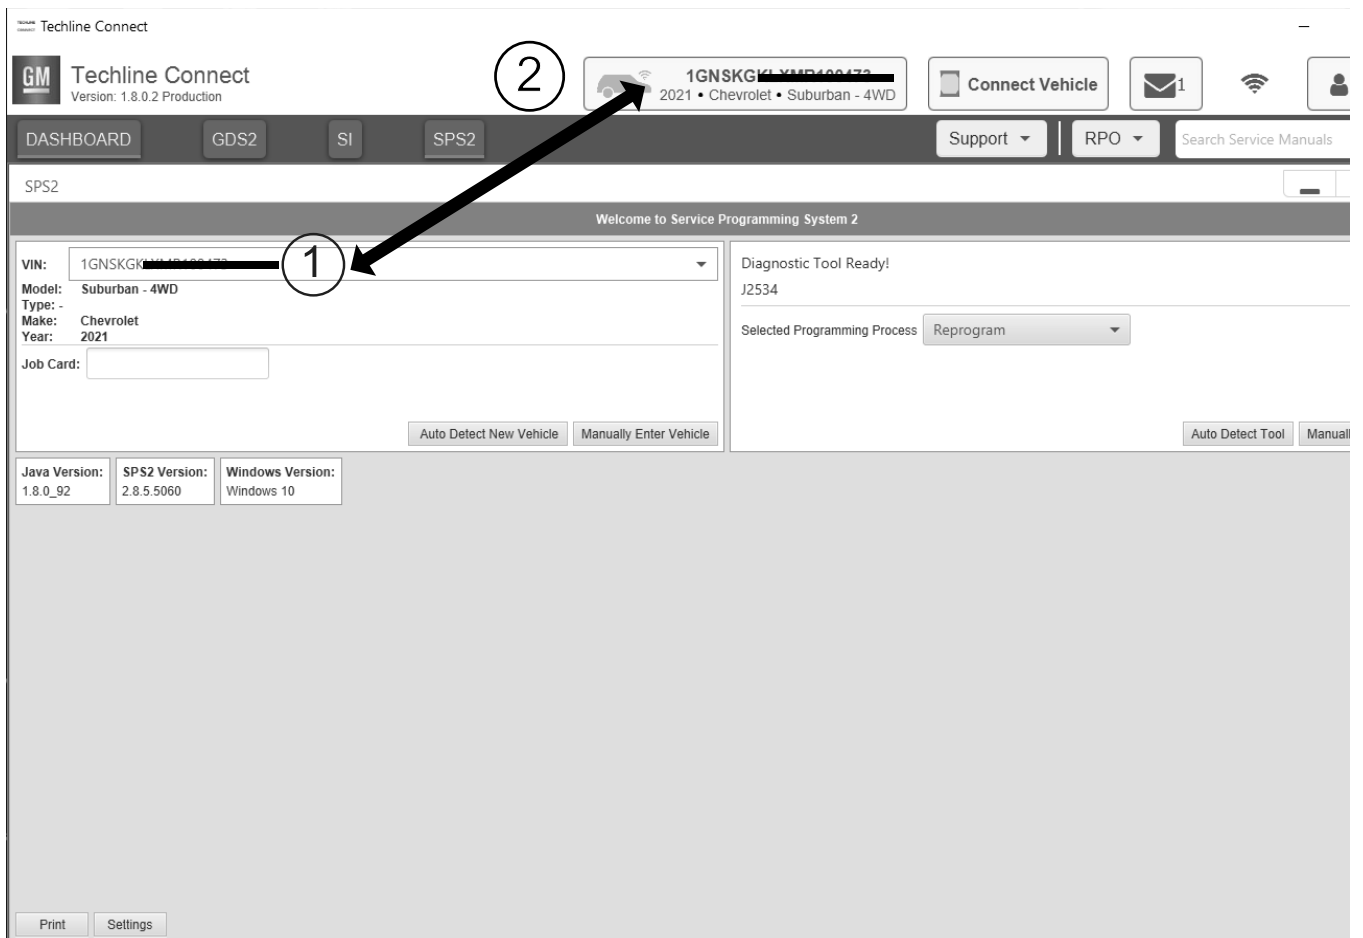
5743643

Caution: Be sure the VIN selected in the drop down menu (1) is the same as the vehicle connected (2) before beginning programming.
