# Service Bulletin

Bulletin No.: 24-NA-277

**Subject: Rear Seat False Latch Concerns**

Brand:	Model:	Model Year:		VIN:		Engine:	Transmission:
		from	to	from	to		
Chevrolet	Equinox EV	2024	2025	-	-	All	All

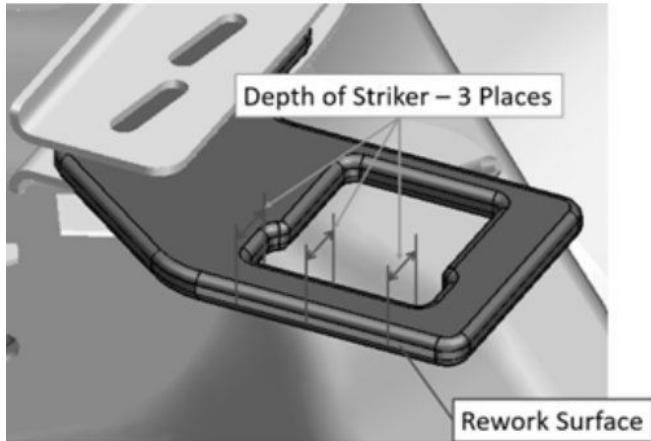
6791542

1. Verify Seat Latch Condition – A false latch condition exists when the red latch indication flag drops without full latch function of seatback latch to striker. When in a false latch condition, seatback latch can disengage from striker without functioning the seat latch release handle.

- 1.1. Measure the striker with calipers or micrometer at three points (as seen in image above).
- 1.2. If striker is larger than 10.7mm, rework to body procedure (Begin Step 2).
- 1.3. If the striker is not larger than 10.7mm, Replace Seat, Contact TAC, and Submit FPR.
