Service Bulletin

Bulletin No.: 17-NA-394

Subject: Squeak, Clunking Type Noise Heard from Rear of Vehicle

Brand:	Model:	Model Year:		VIN:		Engine:	Transmission:
		from	to	from	to		
Chevrolet	Colorado	2015	2025			All	All
GMC	Canyon

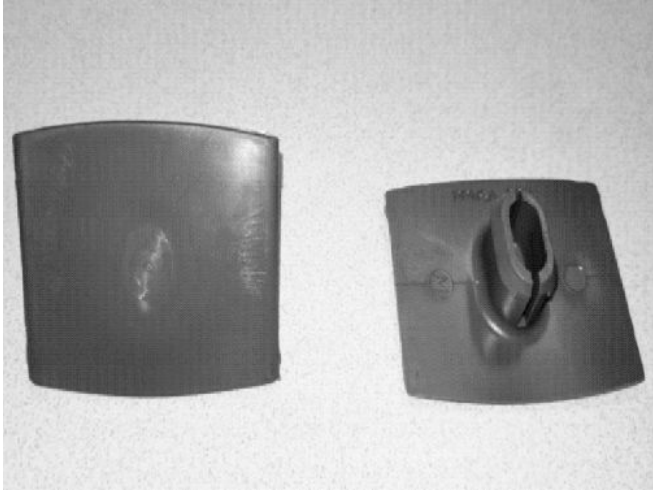
5341853

1. Raise the vehicle on a frame lift-type hoist. Refer to *Lifting and Jacking the Vehicle*, in SI.
2. Inspect the springs for damage.
 - If damage has been found, refer to *Rear Leaf Spring Replacement*, in SI.
 - If damage has NOT been found, proceed to the next step.
