Service Bulletin

Bulletin No.: PIC6589

Subject: Diagnostic Tip: Whistle/Wind Noise at Highway Speeds

Brand:	Model:	Model Year:		VIN:		Engine:	Transmission:
		from	to	from	to		
Chevrolet	Trailblazer	2021-2025		All	All	All	All

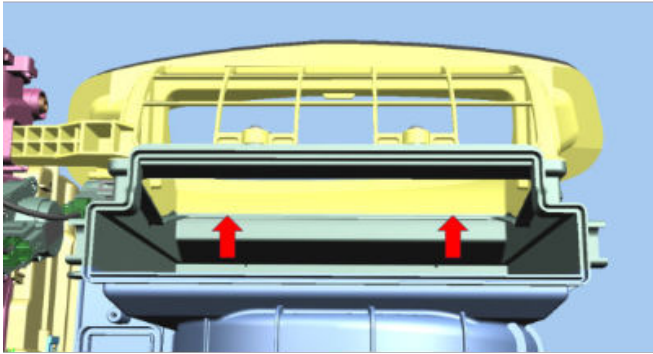
6783054

When the top portion of HVAC case is not seated properly, it is causing a gap at the rear of the HVAC case.

This gap is in the area where the Recirc Door seals, which is why when moving the door, it changes the air flow into HVAC case and alters the noise.

To inspect for this condition, remove the cabin air filter and check for a gap at the rear of the case, between the fresh air inlet duct and recirculation door plenum, see examples below.

Note: This condition is usually caused by a previous repair to the HVAC housing assembly.

To correct for this condition, the HVAC case assembly will need to be removed and reassembled correctly.

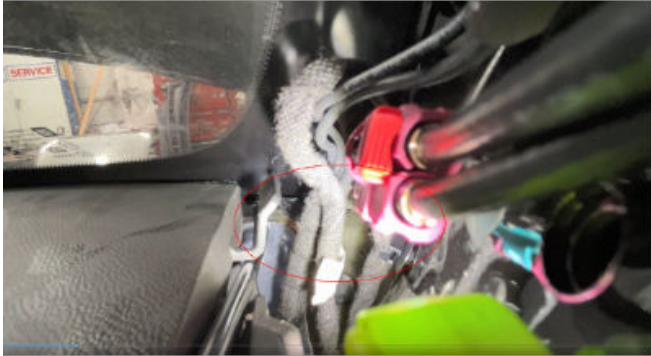
6783053

If the whistle/wind noise is not altered or does not go away and, the noise can be heard from the area shown below.

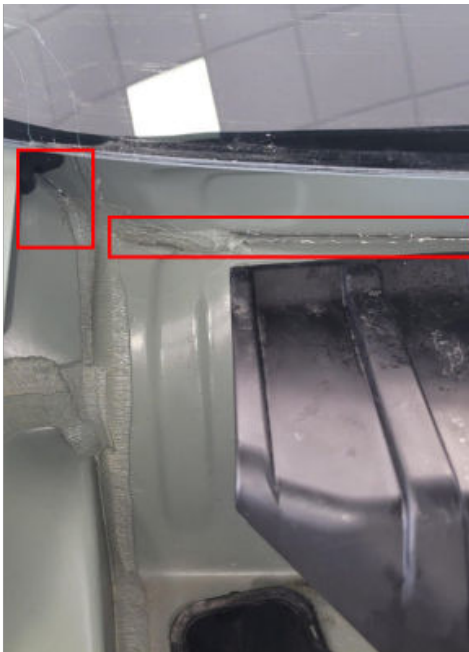
6783046

Inspect the cowl panel for gaps or voids in the seam sealer. See examples below.

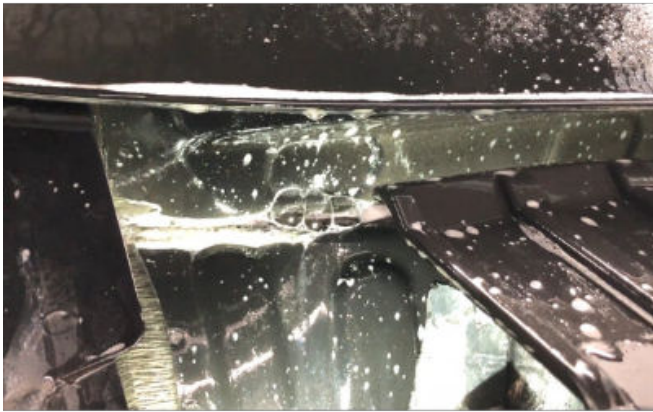
6783049

Using the Soap Suds or Bubble test, SI document 5204781, can be useful in locating the area in the seam that needs repair, see example below.

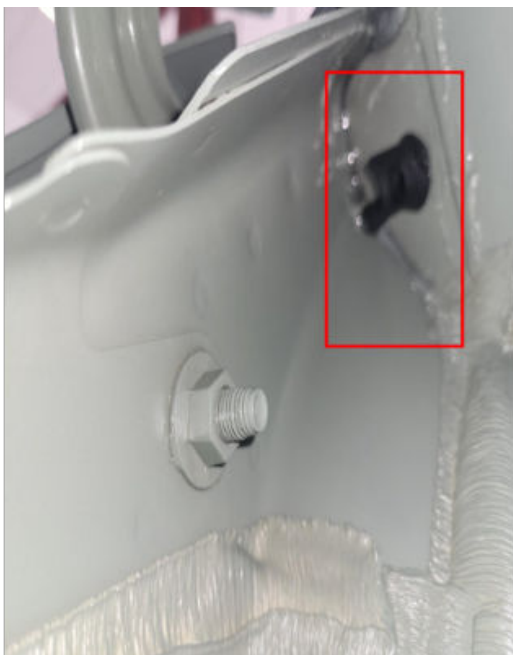
6783047

Technicians will also need to check for leaks in the area shown below.
