MAS004045 RU 25-01

Rapid Update 769 MC20 – Door Compartment Carpet Check

DATE: January 9, 2025

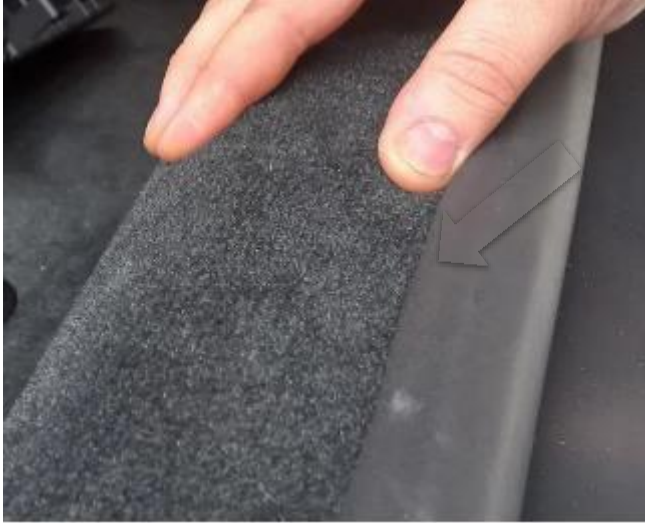
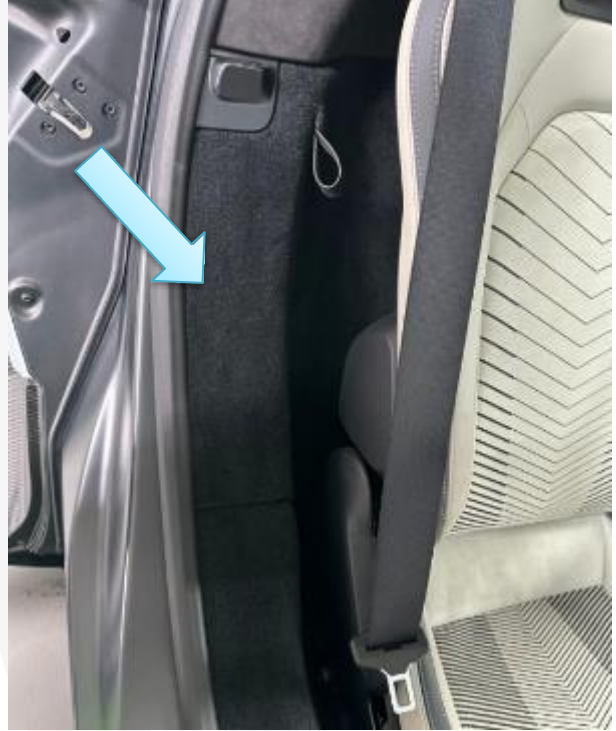
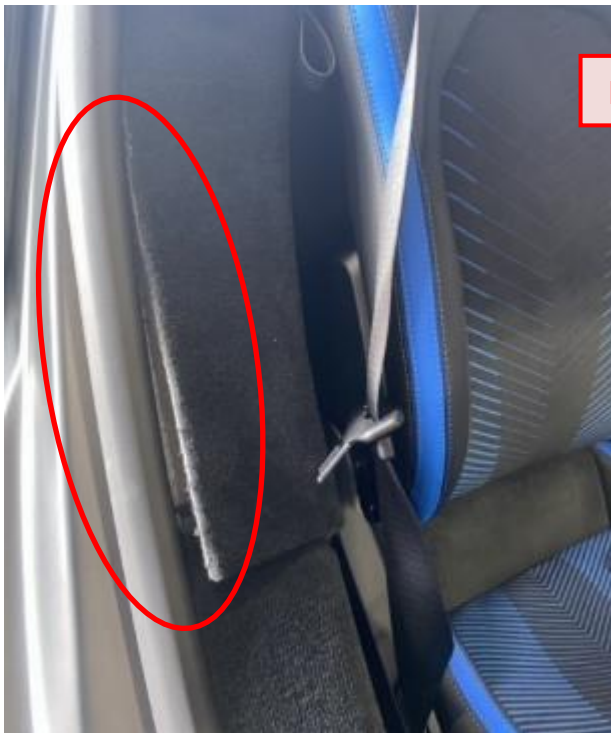
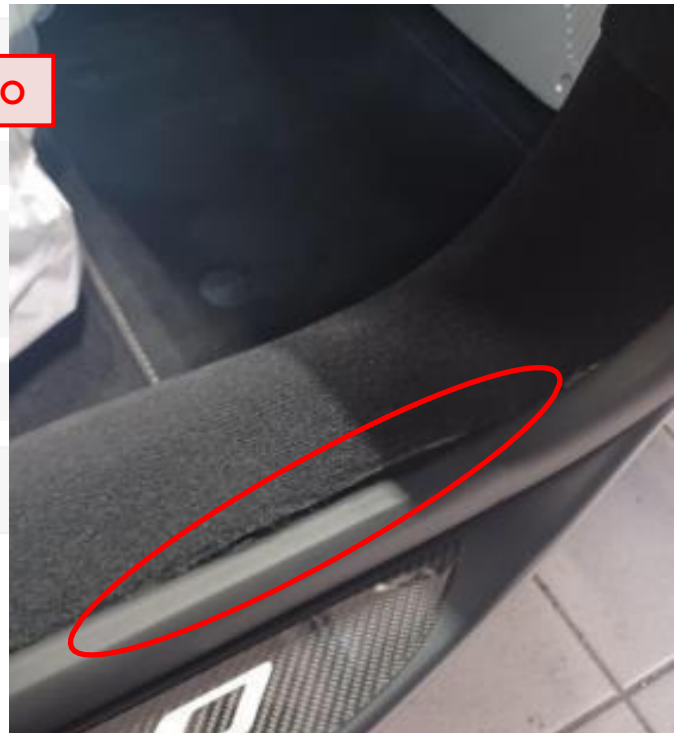
1. Always check ModisCS+ to see if the vehicle is involved in this action and if it has not been previously performed.
2. Before starting, follow the procedure for protecting your interior.
3. Carry out a thorough check of all the carpet that covers the door loop, both in the sill area and in the upright area, checking with your fingers that the carpet does not rise, especially in the area where it joins the gaskets.

Note: Check both the **left** and **right sides** of the vehicle.

4. If you do not notice **any lifting or detachment** of the carpet in any of the controlled areas, the car is **OK** and no other type of intervention is necessary. It is then possible to deliberate the car.

5. If, on the other hand, you notice detachment or lifting of the carpet in the areas analyzed, it is necessary to proceed with the repair, following the procedure indicated in this bulletin. Check all four areas indicated (sill and upright, both right and left).

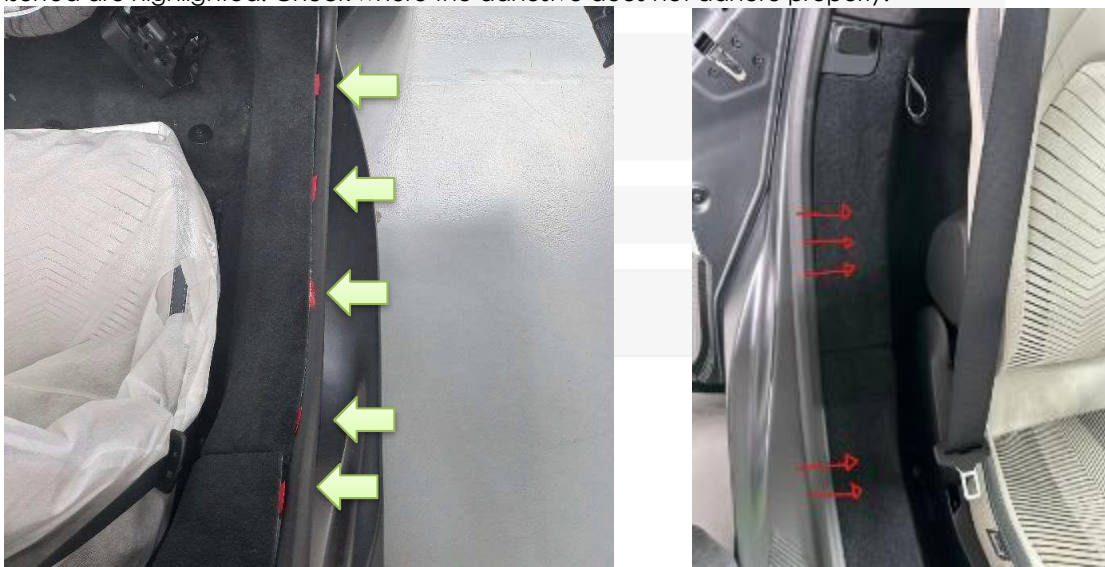
- Identify the area where the carpet is not glued correctly. In the photo below, all the points where the glue is inserted are highlighted. Check where the adhesive does not adhere properly.

- Place the double-sided adhesive patch (PN **670219344**) next to the pre-installed one that is not properly glued.
