Customer Service Notification

M182 MHEV – ECM Software Update

DATE: January 16, 2025

Certain Maserati Grecale MHEV (M182) MY23 MY24 MY25 listed in MODISCS+ are involved in a Customer Service Notification (CSN) to update the Engine Control Module (ECM) software update.

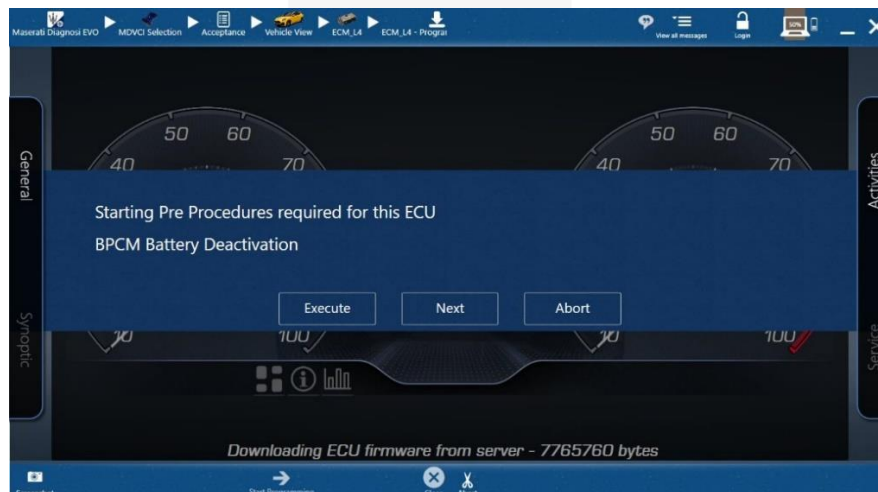
4. Press "Execute" during the pre-procedures:

- Clear all residual DTC's

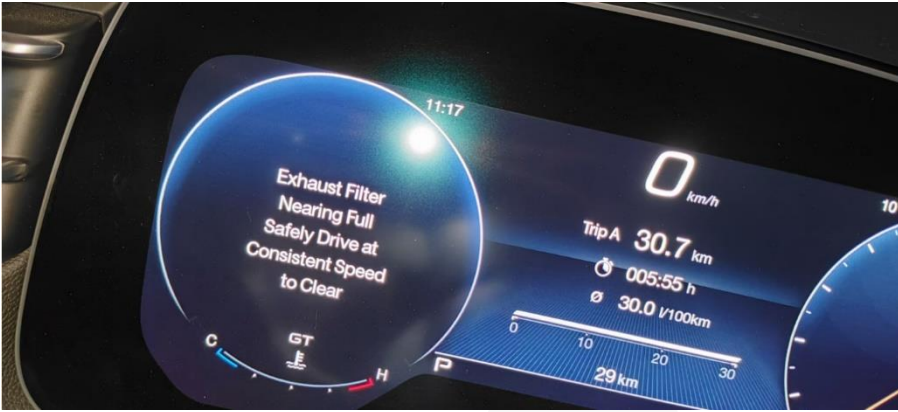
NOTE: Following the update, the following message may appear on the screen in some very rare cases.

This message does not indicate any technical problems with the car and simply suggests that an extra-urban cycle should be performed at cruising speed to facilitate spontaneous GPF regeneration.

Technically, this message is activated when the GPF is about 50% full, in a non-critical condition. In some cases, the message may appear on pre-delivery vehicles if frequent cold engine start/stop cycles have been performed. Again, this message is to be regarded as a technical suggestion and should in no way be seen as a vehicle malfunction.

The reason why this warning has been implemented in this new software version is to inform the customer in good time so that the vehicle can be kept in perfect working order. Therefore, no further action is required by the workshop should this message appear following the update.

We also ask you to inform the customer of both the new warning function and the possible need to drive an extra-urban cycle.
