GENERAL MOTORS
DCS7112
URGENT - DISTRIBUTE IMMEDIATELY

Subject: N242485780 - Service Update
Power Steering Pump – Inspection Procedure

Models: 2024-2025 Chevrolet Express
2025 Chevrolet Silverado 2500 HD/3500 HD
2024-2025 GMC Savana
2025 GMC Sierra 2500 HD/3500 HD

N242485780 Power Steering Pump

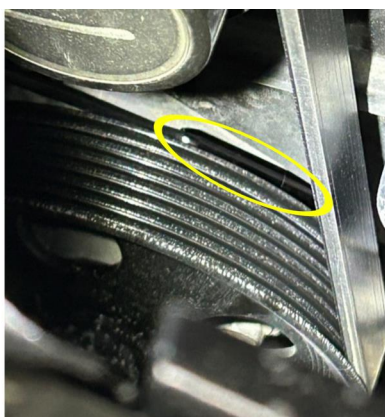
6815800

1. Locate the Power Steering Pump. Refer to *Power Steering Pump Replacement* in SI for component location.

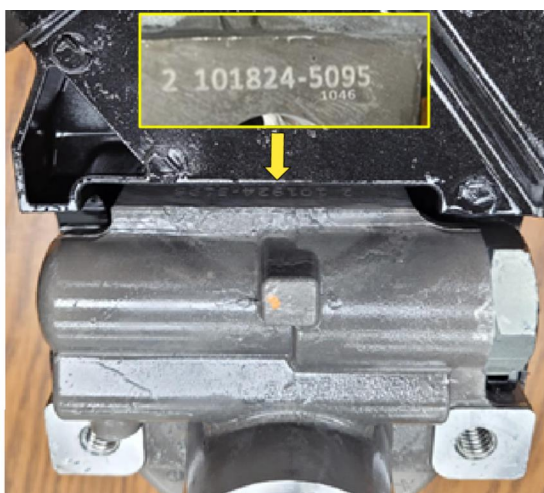
6817376

2. Insert a right-angle borescope behind the power steering pump pulley, from the most accessible side horizontally along the top edge of the Power Steering Pump. The date code and lot code are located on a flat between the reservoir and pump body as pictured below. Angle the camera towards the engine, as the codes are inside of the gap beneath the reservoir.

Note: Pulley removed to show location, it is **NOT** required to remove the pulley for borescope inspection

3. Verify the Date Code Range (6 digit) does not fall between 100424 and 102624.
 - If the code **IS NOT** between 100424 and 102624, the power steering pump is within specification and no further action is required.

- If the code **IS** between 100424 and 102624, proceed to step 4.
4. Verify the Lot Code Range (4 digit) is not within the 5000 series, seen as 5xxx.
 - If the code **IS** within the 5xxx Lot Code Range, the Power Steering Pump has failed inspection. Remedy parts are not available and the field action cannot be closed at this time.

- If the code **IS NOT** within the 5xxx Lot Code Range, the power steering pump is within specification and no further action is required.
 - If the inscribed date and lot ranges cannot be read with the borescope due to corrosion or damage to the inscription, clean the surface with a suitable cleaning agent. If the inscribed date and lot ranges still cannot be read after cleaning, the power steering pump has **FAILED** inspection. Remedy parts are not available and the field action cannot be closed at this time. **Important:** Involved vehicles in dealer inventory that **DO NOT PASS** the inspection procedure **MUST** be held and not delivered to customers. The bulletin will be revised when parts and the repair procedure are available.
