Service Bulletin

Bulletin No.: 23-NA-222

Subject: Radio Software Version W26E-172.4.2-M169-SQBR4-123.4 – Multiple Updates for IVD

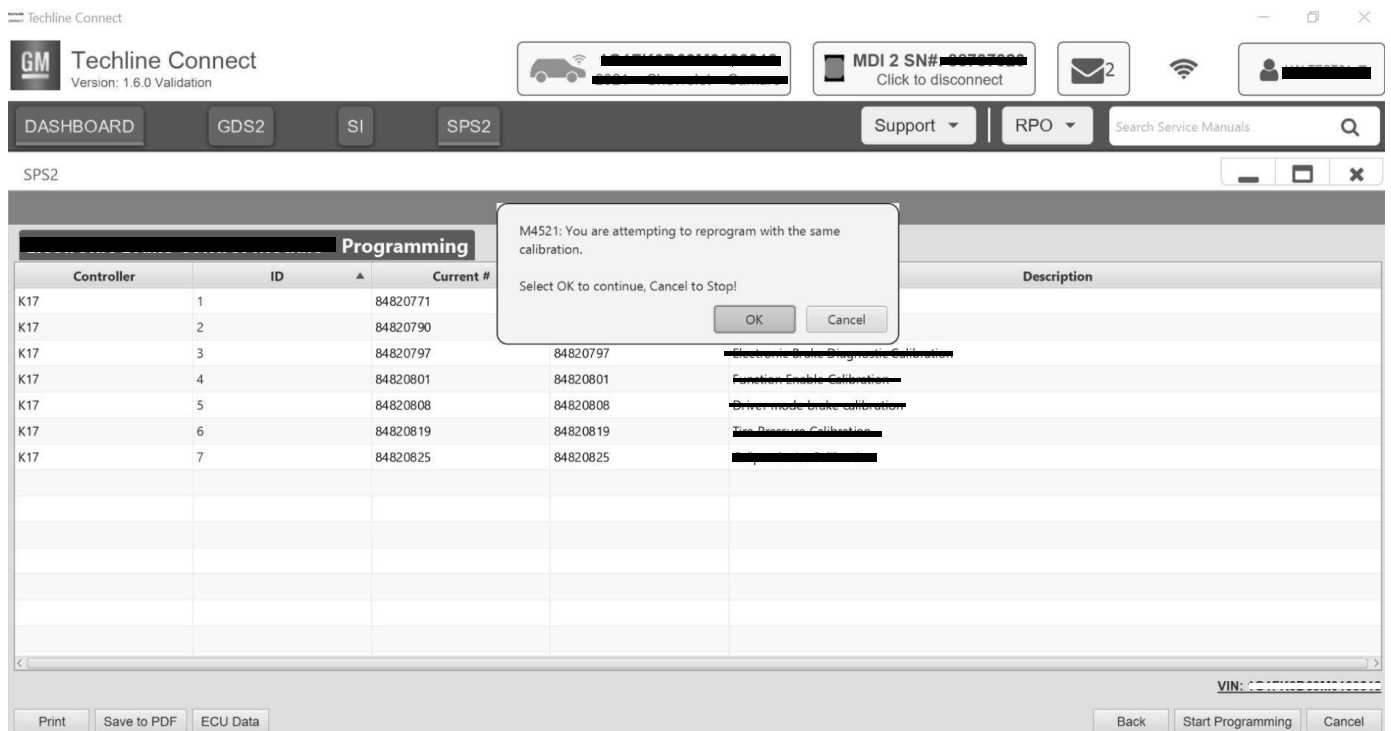
5644477

Important: Techline Connect screen is shown above.

Important: If the same calibration/software warning is noted on the TLC Summary screen, select OK and follow screen instructions. After a successful programming event, the WCC is located in the Service Programming System dialogue box of the SPS Summary screen. Document the WCC on the job card. No further action is required. Refer to the Warranty Information section of this bulletin.

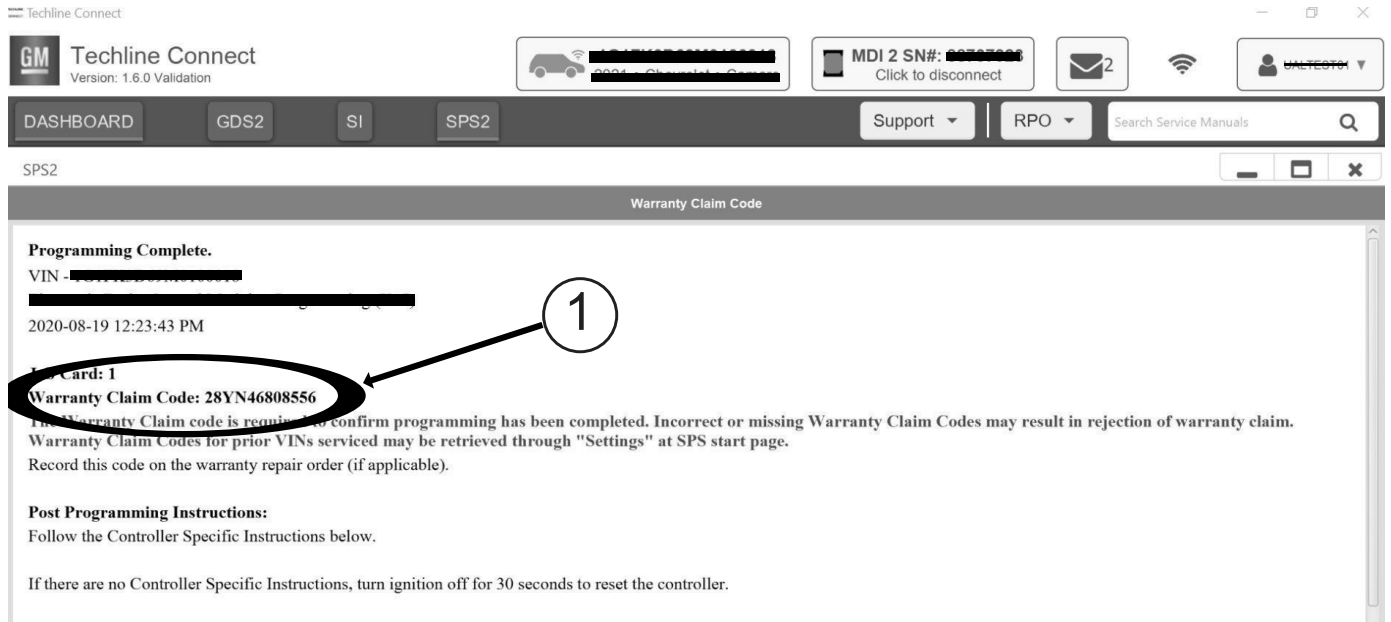
5644478

Note: The screenshot above is an example of module programming and may not be indicative of the specific module that is being programmed. Module selection and VIN information have been blacked out.

Important: To avoid warranty transaction rejections, you MUST record the warranty claim code provided on the Warranty Claim Code (WCC) screen shown above on the job card. Refer to callout 1 above for the location of the WCC on the screen.

- Record the SPS Warranty Claim Code on the job card for warranty transaction submission.
