SIB 01 19 24

## F48 TCU EMERGENCY BATTERY EXTENDED LIMITED WTY (ELW) 6 YRS WITH NO MILEAGE LIMIT

This Service Information bulletin (Revision 01) supersedes SI B01 19 24 **dated December 2024**

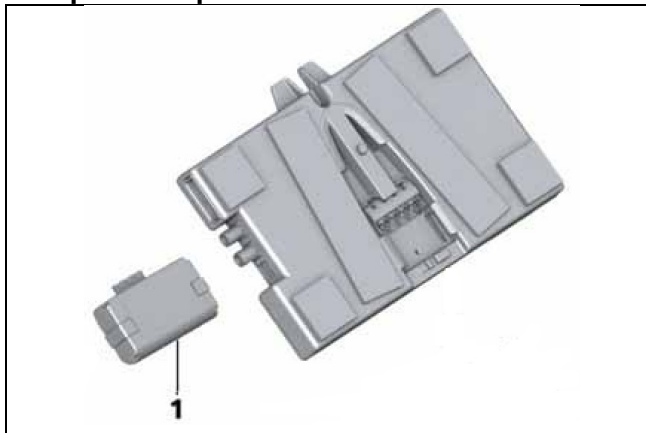
For the eligible vehicles, BMW of North America, LLC (BMW NA) is extending the coverage for the vehicle's **Telematics Control Unit's (TCU) Emergency (Backup) Battery (Item # 1)** to:

The vehicle's Telematics Control Unit's Internal Emergency (Backup) Battery may not meet BMW's operational standards because it may have faulty cells and/or its overall performance in varying outside temperature conditions may be less than what is optimally required.

Should a situation like this occur, it may affect the operation of the vehicle's Telematics system. If that should happen, the vehicle's monitoring system will generate and show the corresponding Check Control Messages (CCM) in the vehicle's display, for example:

If a vehicle listed above arrives at your center with the issue described in this Service Information Bulletin, perform the corresponding diagnosis and when applicable, replace the Telematics Control Unit's internal emergency battery as instructed or as determined by the diagnosis.
