SIB 51 02 25

CLICKING SOUND FROM THE DRIVER'S SIDE FOOTWELL AREA

E-Series	Model Description
i20	iX Sports Activity Vehicle

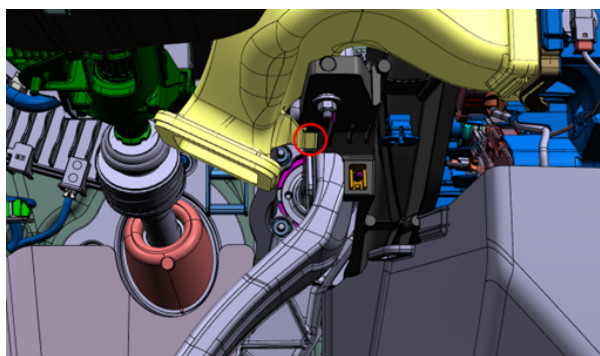
While driving on a smooth and/or uneven road, a “clicking” sound is heard from the driver’s footwell area.

The clamp that secures the floor air duct has an unfavorable retaining force.

Note: Photo is showing the clip (circled) on the air duct that is creating the clicking sound.

Apply felt tape on the dashboard carrier tab that secures the floor air duct.

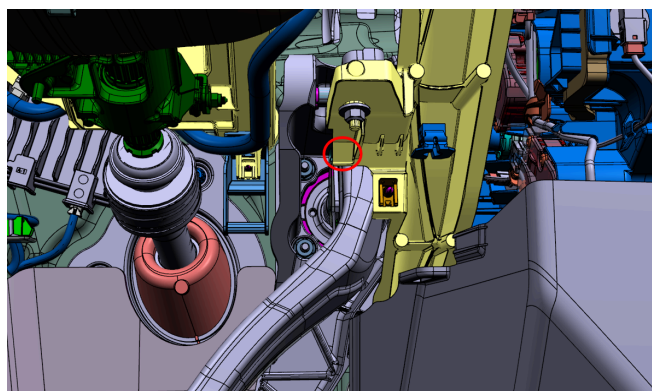
Note: Photo is showing the tab on the dashboard carrier circled in red.

4. Apply felt tape around the area of the dashboard carrier that the air duct clips onto.
