SIB 54 03 24

CONVERTIBLE TOP DOES NOT OPEN/CLOSE

E-Series	Model Description	Production Date
G29	Z4 Roadster	After January 1, 2018 – January 19, 2024

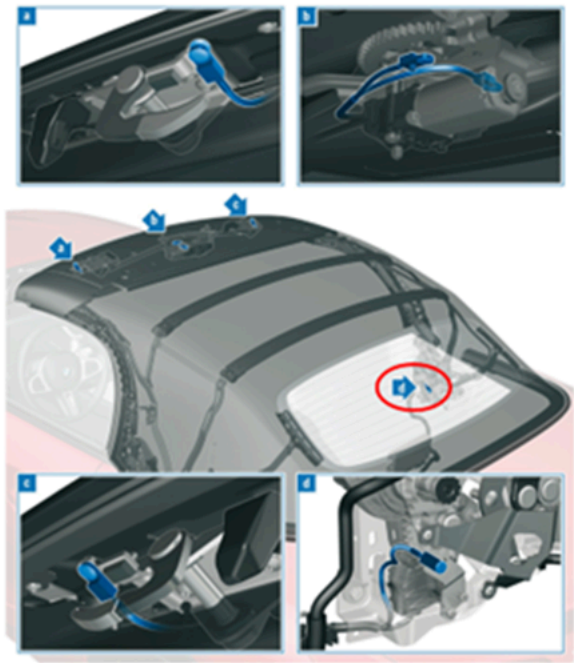
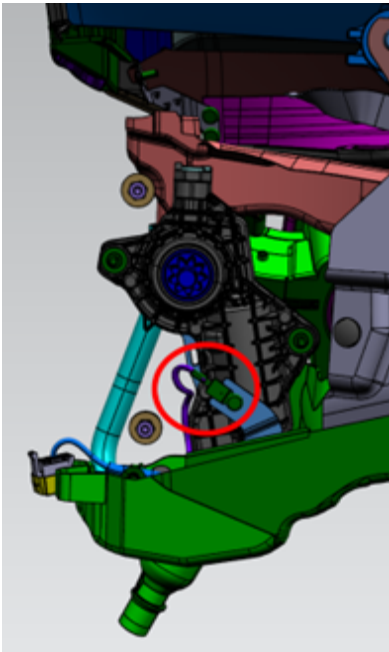
The Hall effect sensor falls out of the convertible top linkage.

Photo is showing where the Hall effect sensor is located.

Replace the Hall effect sensor.

4. Replace the Hall effect sensor D (circled).
