SIB 61 01 24

2025-01-06

RATTLING NOISE ORIGINATING FROM WINDSHIELD WASHER FLUID RESERVOIR

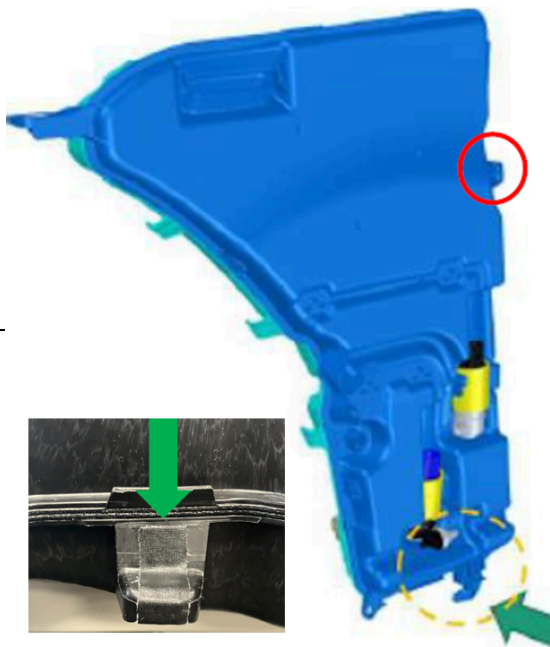
When driving over rough surfaces, a low-frequency rattling noise can be heard inside the vehicle's cabin. The noise typically sounds as though it is coming from the front right footwell area.

The washer fluid reservoir mounting hook has too much play, which allows the reservoir to vibrate and cause a noise.

Replace the washer fluid reservoir.

1. Inspect the washer fluid reservoir for play or looseness, check the mounting points or areas where contact may occur.
2. Confirm the source of the noise is the washer fluid reservoir.
3. If the noise is determined to originate from the reservoir, replace it with the improved part listed below.
4. Follow the repair instructions “**Replacing the washer fluid reservoir for the washer system 61 71**”.
