GENERAL MOTORS
DCS7120
URGENT - DISTRIBUTE IMMEDIATELY

Subject: REVISION: N242490440-01 – Service Update
Multiple Module Reprogramming
Revised Service Procedure and Warranty sections

Models: 2025 Cadillac Escalade IQ

N242490440 Multiple Module Reprogramming

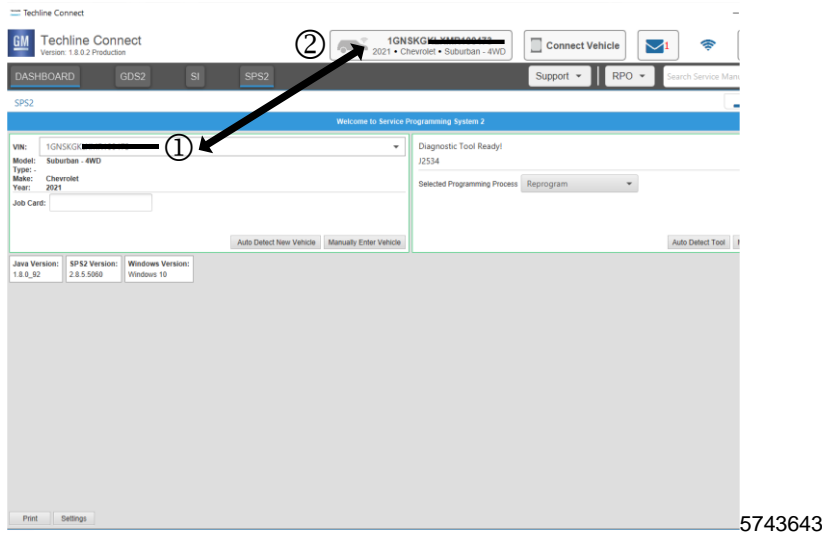
Caution: Be sure the VIN selected in the drop-down menu (1) is the same as the vehicle connected (2) before beginning programming.

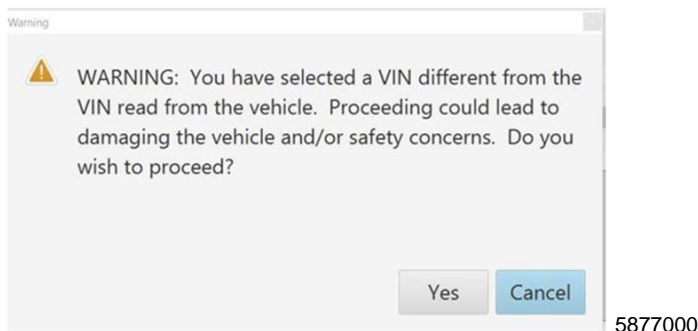
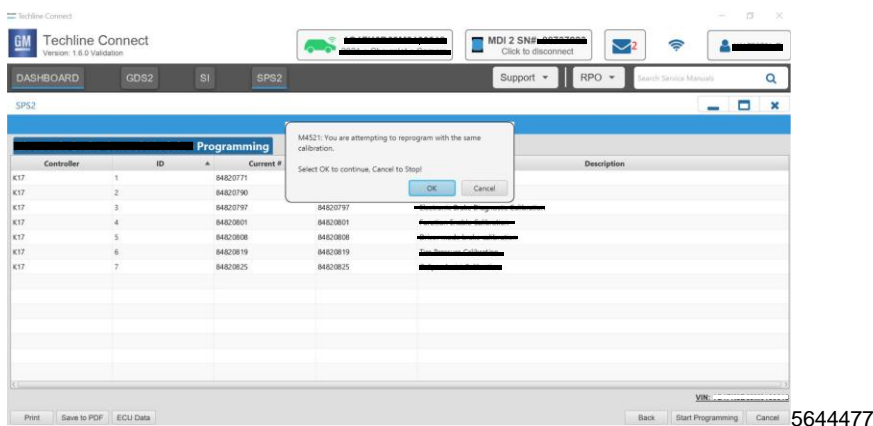
Important: If the vehicle VIN DOES NOT match, the message below will be shown.

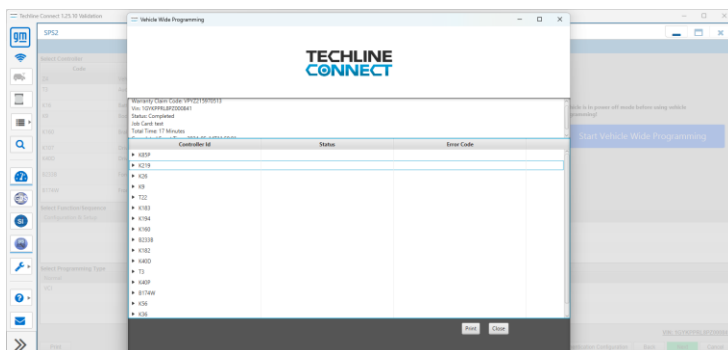
6693875

Note: The screenshot above is an example of Vehicle Wide Programming and may not be indicative of the specific modules that are being programmed. VIN information has been blacked out.

Important: To avoid warranty transaction rejections, you MUST record the Total Time provided on the Warranty Claim Code (WCC) screen shown above on the job card.
