SIB 63 03 24

EXTERIOR MIRROR ASSEMBLY WELCOME LIGHT IMAGE DISTORTED

E-Series	Model Description
U10	X2 Sports Activity Coupe
U11	X1 Sports Activity Vehicle

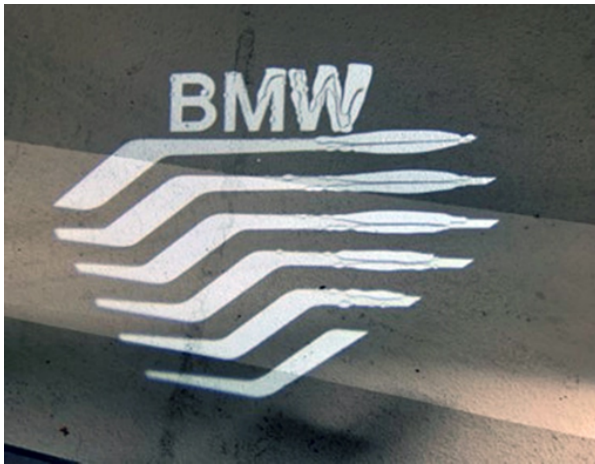
The welcome light image displayed from the exterior mirror assembly is distorted.

Delamination of the film on the LED module due to heat.

Replace the light module in the affected exterior mirror assembly.
