SIB 65 01 22

## KNEE AIR BAG CCM G01 VARIANT WIRE HARNESS REPAIR CABLE EXT LTD WTY (ELW) 10/120

This Service Information Bulletin (Revision 7) replaces SI B65 01 22 **dated November 2023**.

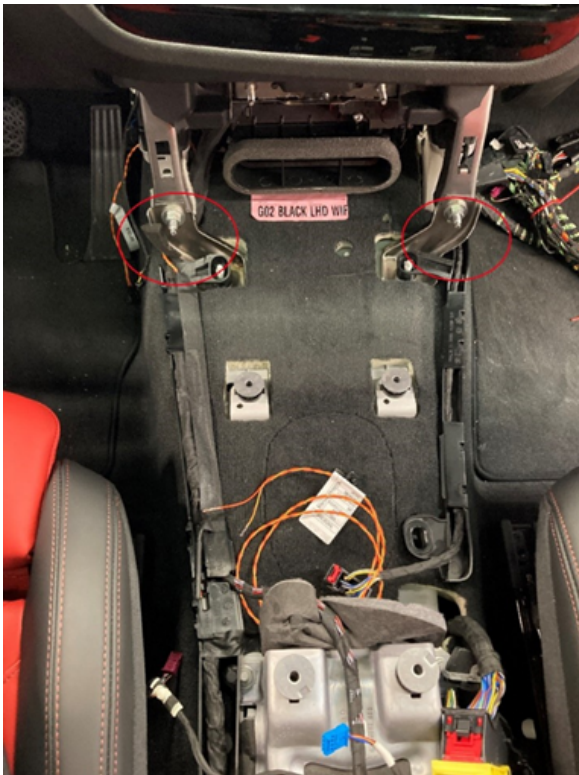
Over time, the wiring harness going to the knee air bag(s) can rub against the metal support tubes for the instrument panel, chafing and damaging the wiring.

5- Apply felt tape to the locations pictured.

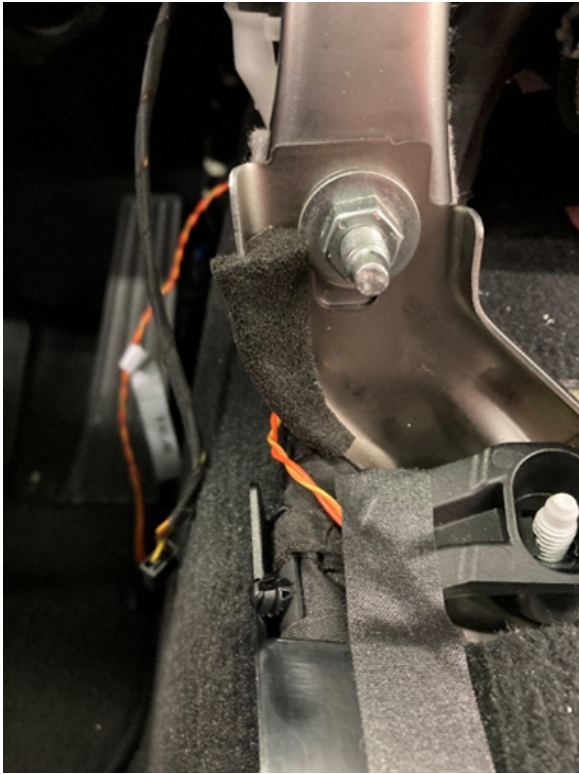
6- The knee air bag wiring should be protected from chafing at the dash support bracket.

Glue the felt generously onto the support tube or to the corresponding edge.
