SIB 65 02 22

## KNEE AIR BAG CCM G05 VARIANT WIRE HARNESS REPAIR CABLE EXT LTD WTY (ELW) 10/120

This Service Information Bulletin (Revision 7) replaces SI B65 02 22 **dated August 2023**.

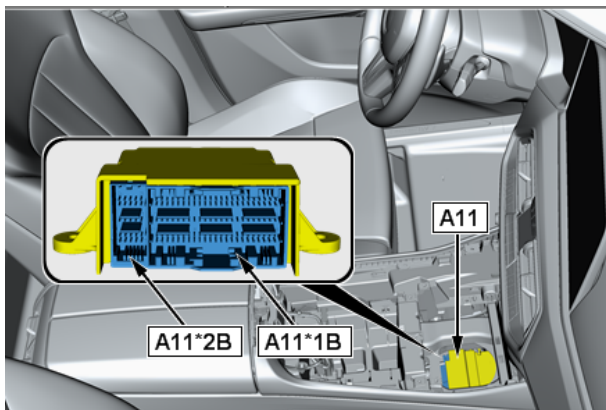
Check the ACSM module for signs of corrosion within the electrical connector.

2- Remove the **center console** as per **Repair Instructions 51 16 165** to access the Air Bag Control Module **A11 (ACSM)** wiring connector (**A11\*2B**).

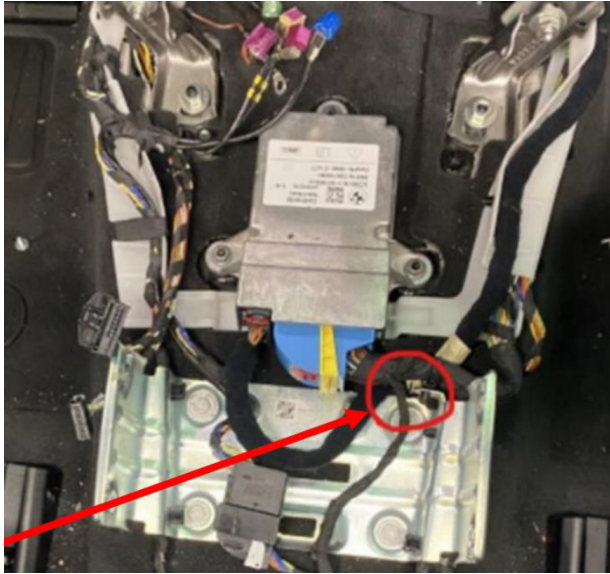
Over time, the wiring harness going to the knee air bag(s) can rub against the metal support tubes for the instrument panel, chaffing and damaging the wiring.

6. Cover the edge of the center console support (the edge inside the circle) with felt tape (part number **54 34 7 248 700**).
