Service Bulletin

Bulletin No.: 20-NA-166

Subject: Information on Malfunction Indicator Lamp (MIL) Illuminated – DTCs P050D and/or P0300 Setting on a Cold Start and/or Engine Runs Rough when Warm with No Codes

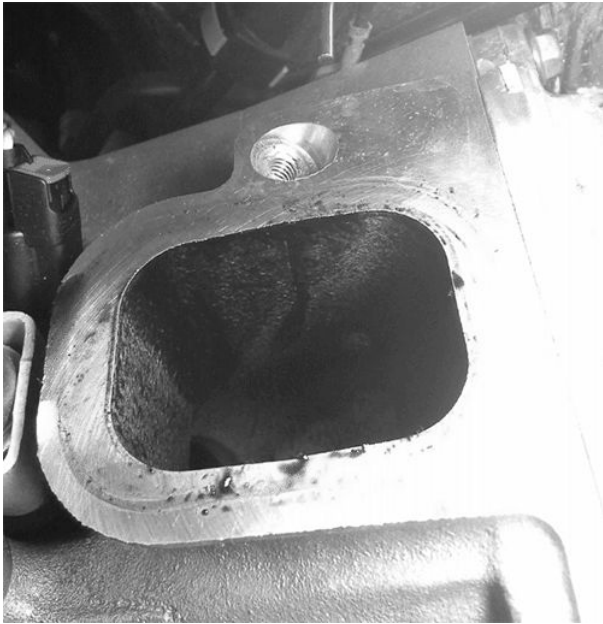
4806659

If the head casting line is the concern, the intake port will be wet with a coolant oil mix.

The location of where the coolant is running down in the port will also look washed down.

If this is found, the cylinder head will need to be replaced.

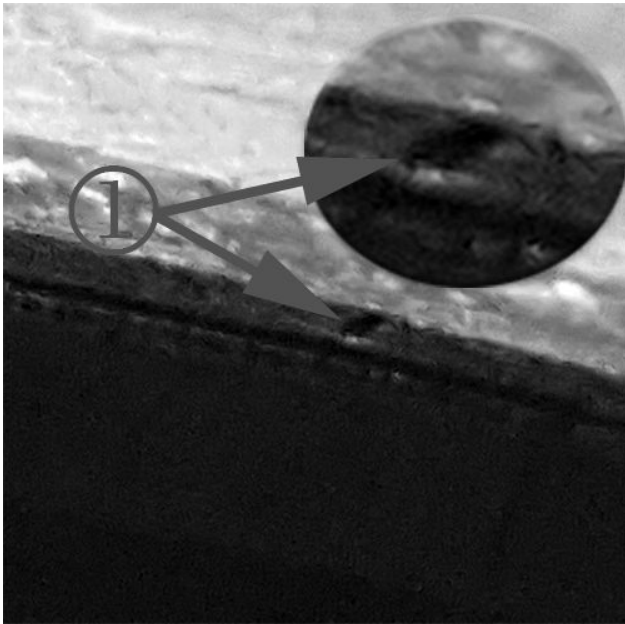
4806657

It is also possible to have coolant entry at the liner to deck face casting of the cylinder bore (1). It is hard to see the actual source (pin hole), but it usually streams down the liner so that you can see it with a borescope. (Sometimes) The top of the piston will be steam cleaned.

Do not confuse residual fuel on the piston crown / surface as coolant. Some fuel residue may be present and can be mistaken as coolant (reason for the cooling system Dye to be added). Use a black light to confirm the liquid is coolant. If this concern is present, do not replace the cylinder head because that will not repair this concern. Call the Product Quality Center (PQC) per Service Bulletins 20-NA-138 (U.S.) or 16-NA-338 (Canada), if required, reference this bulletin and replace the engine.
