Service Bulletin

Subject: Vehicle Wide Programming Instructions

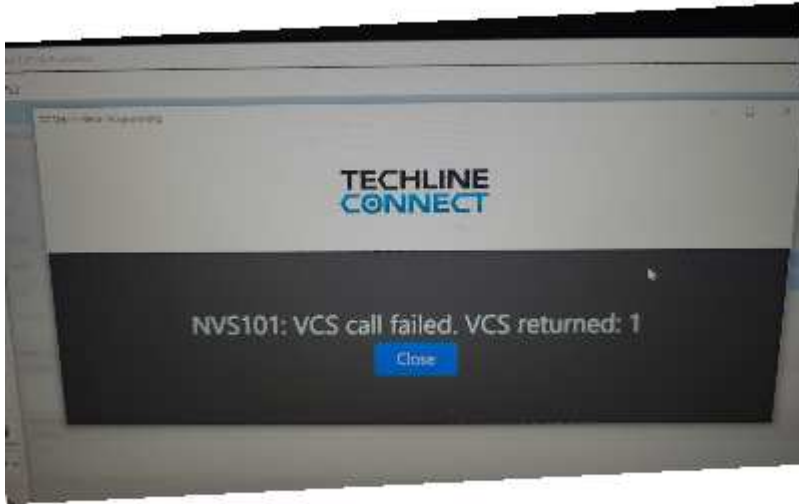
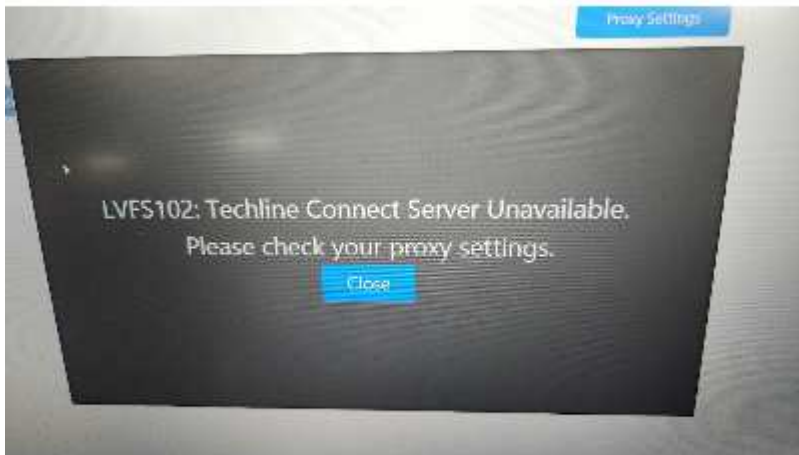
Note: If either of the following errors are received, this indicates a Techline connection concern. The recommended course of action is to exit from TLC completely and try again. If either failure persists, reboot the machine.
