M274 Check engine light, P052E71 Crankcase ventilation valve

Topic number	LI01.20-P-076894
Version	7
Function group	01.20 - Crankcase ventilation, cylinder head cover
Date	1/17/25
Validity	Passenger car with engine M274
Reason for change	Remedy updated

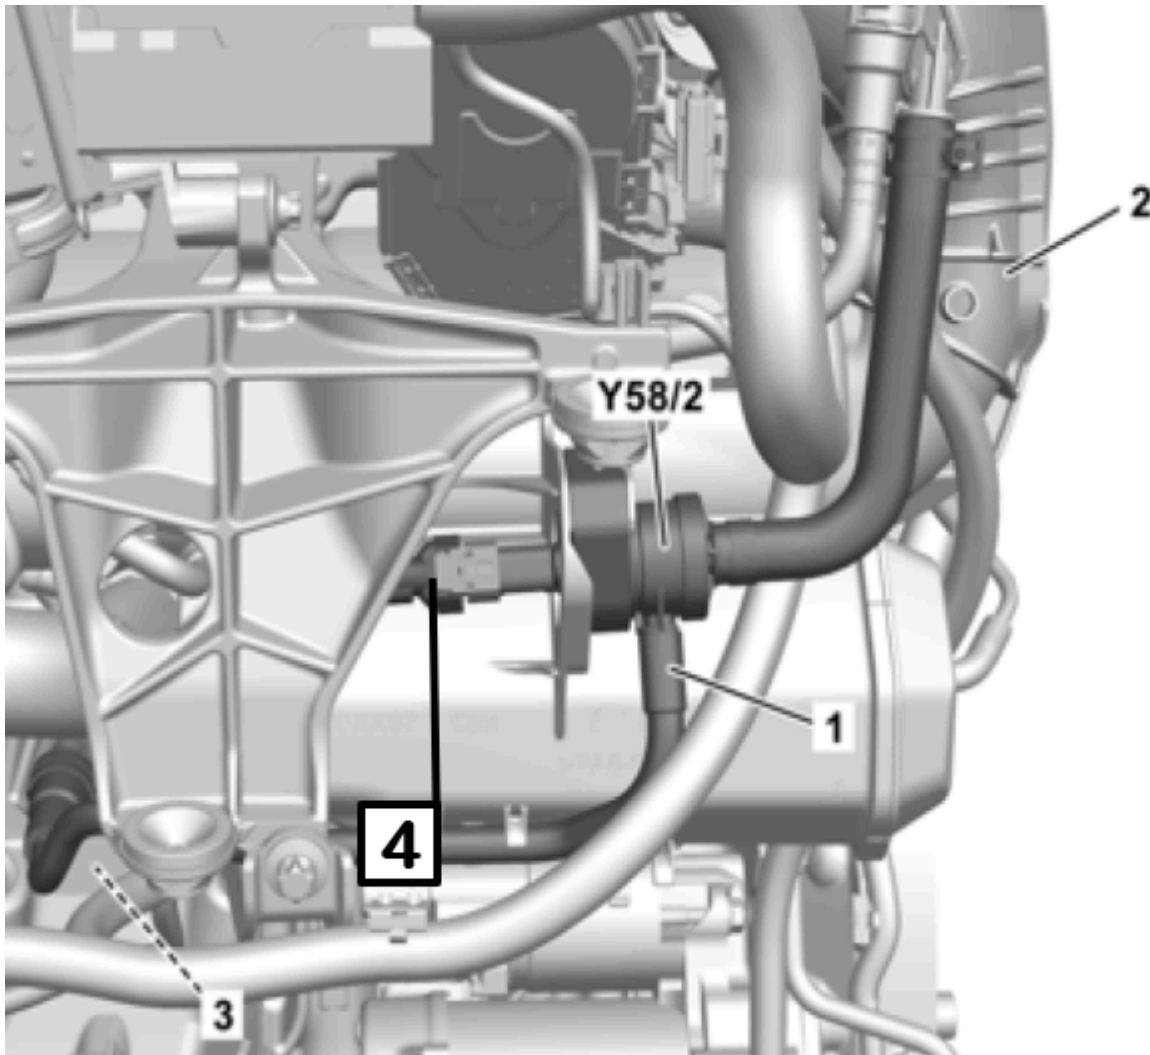
The partial-load ventilation valve (a part of the intake line assembly) may not work as intended.

- 1- Perform software update for N3/10 Engine control unit.
- 2- Remove upper engine cover.
- 3- Unclip ME-SFI control unit (N3/10) with bracket and place to one side with connected lines (see AR07.08-P-7013M-RD).
- 4- Release and disconnect electrical connector (4) of partial-load operation crankcase ventilation valve (Y58/2).

5- Fit cap A094 545 50 03 on electrical connector (4) of engine wiring harness partial load operation crankcase ventilation valve (Y58/2) and ensure correct seating on plug of electrical connector (4).

6- Strap down electrical line (4) of partial load operation crankcase ventilation system valve (Y58/2) at wiring harness. Ensure that electrical line (4) is routed free of tension.
