SIB 51 22 24

2025-01-09

MAIN DOOR SEAL DETACHING AT THE SEALING JOINT

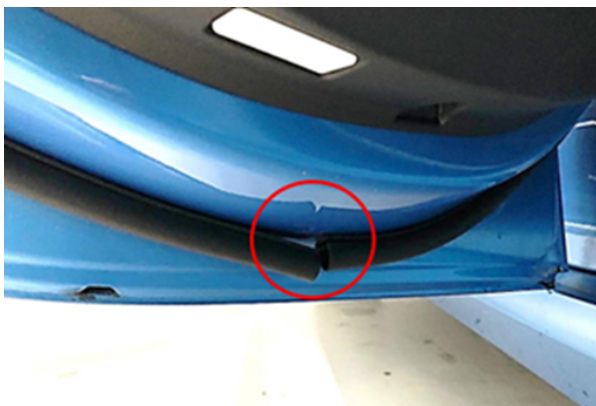
On the main door seal, detachment behavior can be detected in the sealing joint area.

Overtime, the sealing material continues to detach more and more, which can cause the seal to dangle and become visible to the customer.

Contamination of the surface onto which the door seal bonds/adheres.

Partially replace the affected main door seal.
