Technical Service Bulletin (TSB)

Keyfob Not Detected When Near Wireless Charger

REFERENCE:	TSB: 08-016-25 GROUP: 08 - Electrical	Date:	January 23, 2025	REVISION:	08-232-24
VEHICLES AFFECTED:	2025 (DT) RAM 1500 Pickup This bulletin applies to vehicles equipped with a Wireless Charging Pad (Sales Code RFX) and Dual Wireless Charging Pad (Sales Code CMS).			MARKET APPLICABILITY: <div><input checked="" type="checkbox"/> NA<input checked="" type="checkbox"/> MEA <input checked="" type="checkbox"/> SA<input checked="" type="checkbox"/> IAP <input type="checkbox"/> EE<input type="checkbox"/> CH</div>	
CUSTOMER SYMPTOM:	Customers may comment on the following: <ul style="list-style-type: none">Keyfob intermittently is not detected when the keyfob is placed at or near the wireless charger.				
CAUSE:	Radio Frequency (RF) interference

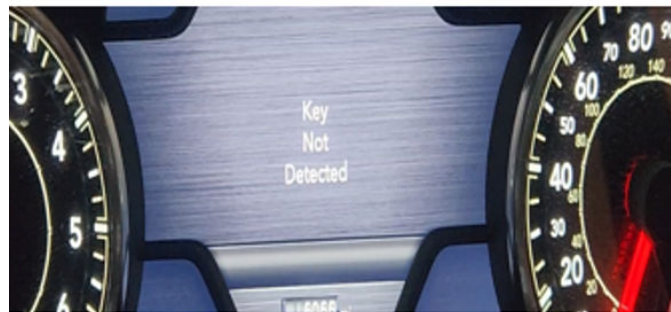
Fig. 1
Key Not Detected

When the ignition is OFF, and the keyfob is near an active wireless charger, interference can occur leading to the keyfob not being detected by the vehicle [Fig. 1](#). The keyfob needs to be at least 203 mm (8 in.) away from the wireless charger and/or do not put the phone on the wireless charger before the ignition is ON.

NOTE: **DO NOT replace the wireless charger.**
